Details of Proposed Work

Drumin Castle: Location and remedial work

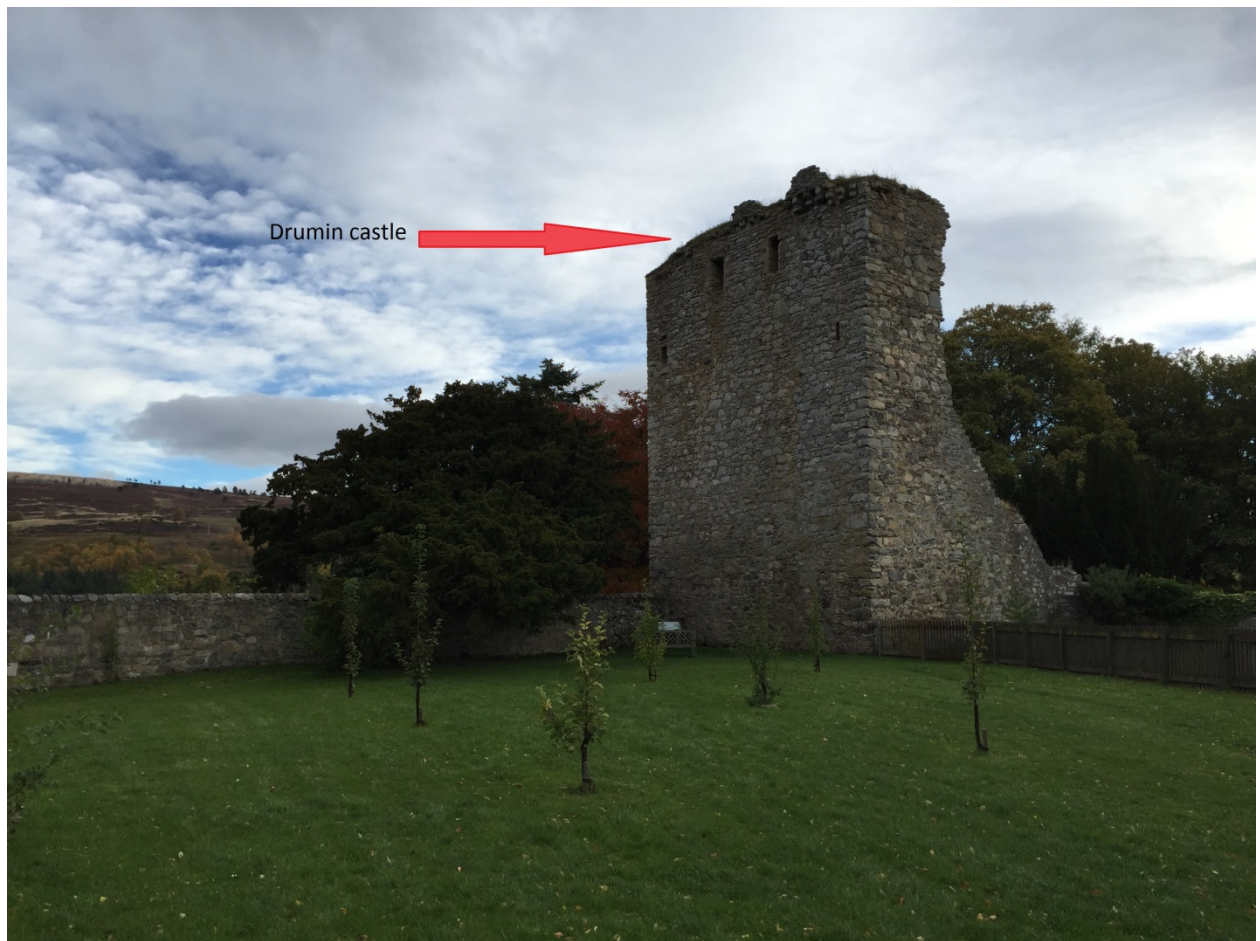
The building has a square floor plan with 2m thick walls and is predominantly intact. However the East wall and part of the South wall are missing. The building is generally in good repair but there is vegetation growth, cracks and bulging to walls and the sue of improper mortar in walls that needs to be raked out and replaced with that with that which is similar to the original mortar.
