| MONUMENT | BOTHWELL CASTLE |
| PROJECT | LATRINE TOWER CONSOLIDATION WORKS<br>SHAFT AND INTERIOR CONSOLIDATION DETAILS |

| PROJECT DRAWING NUMBER | | 90038-150714-003B | |

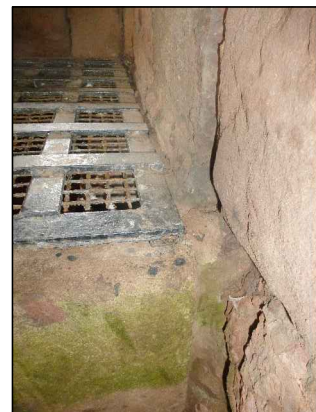
Defective and corroded yett fixings. Fixings to be cut out to allow removal of yett, with new fixings into stonework joints being used to re-install yett once condition inspection of shaft and any necessary repairs have been completed.
