HUNTLY CASTLE

Survey of stone frieze and other ornamental stone

September 2015

Applied Conservation - Stone
Conservation Group
7 South Gyle Crescent
Edinburgh EH12 9EB
Tel: 0131-334 6367
Fax: 0131-334 6810

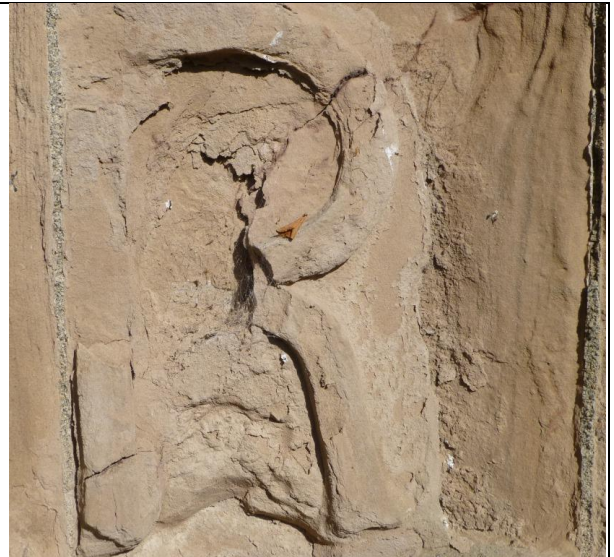
Stone after removal of the letter 'R'
