**HISTORIC ENVIRONMENT SCOTLAND  
PROPERTIES IN CARE  
MINOR ARCHAEOLOGICAL WORKS 2016/2017**

**Kinneil House • Watching Brief • April 2016**

**SITE:** Kinneil House, near Bo'ness, West Lothian.

**DESCRIPTION:** Archaeological watching brief during the excavation of two test trenches against the north face of the south orchard wall ahead of stabilisation works.

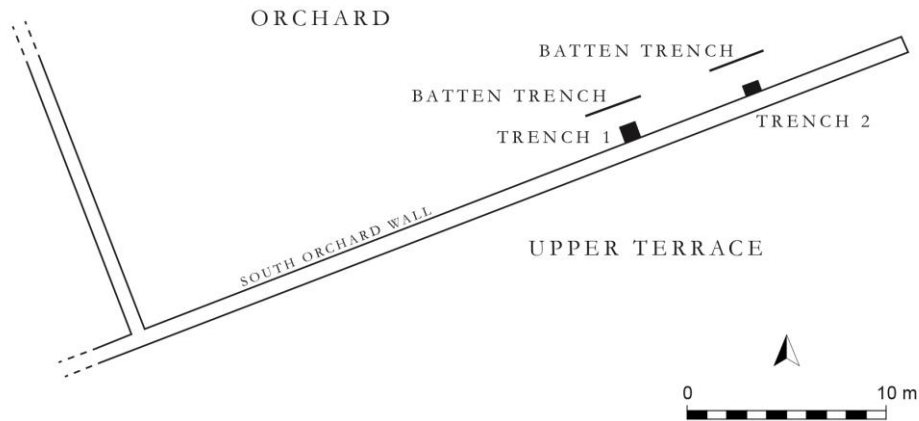
Figure 2: Location plan of the two trenches.

As the south orchard wall was leaning heavily to the north, and as the test trenches were positioned on that side of the wall, the wall first had to be propped. This required two long shallow trenches (4.30m E/W x 0.35m N/S x 0.15m deep, through disturbed topsoil) to be excavated in order to recess long battens running parallel to the wall. These would provide the footing for the diagonal braces holding the wooden frameworks against the wall face over the position of each test trench.
