# The Chesters, Drem, East Lothian

## Erosion Survey

Rampart Scotland Project 002:

### Season 4

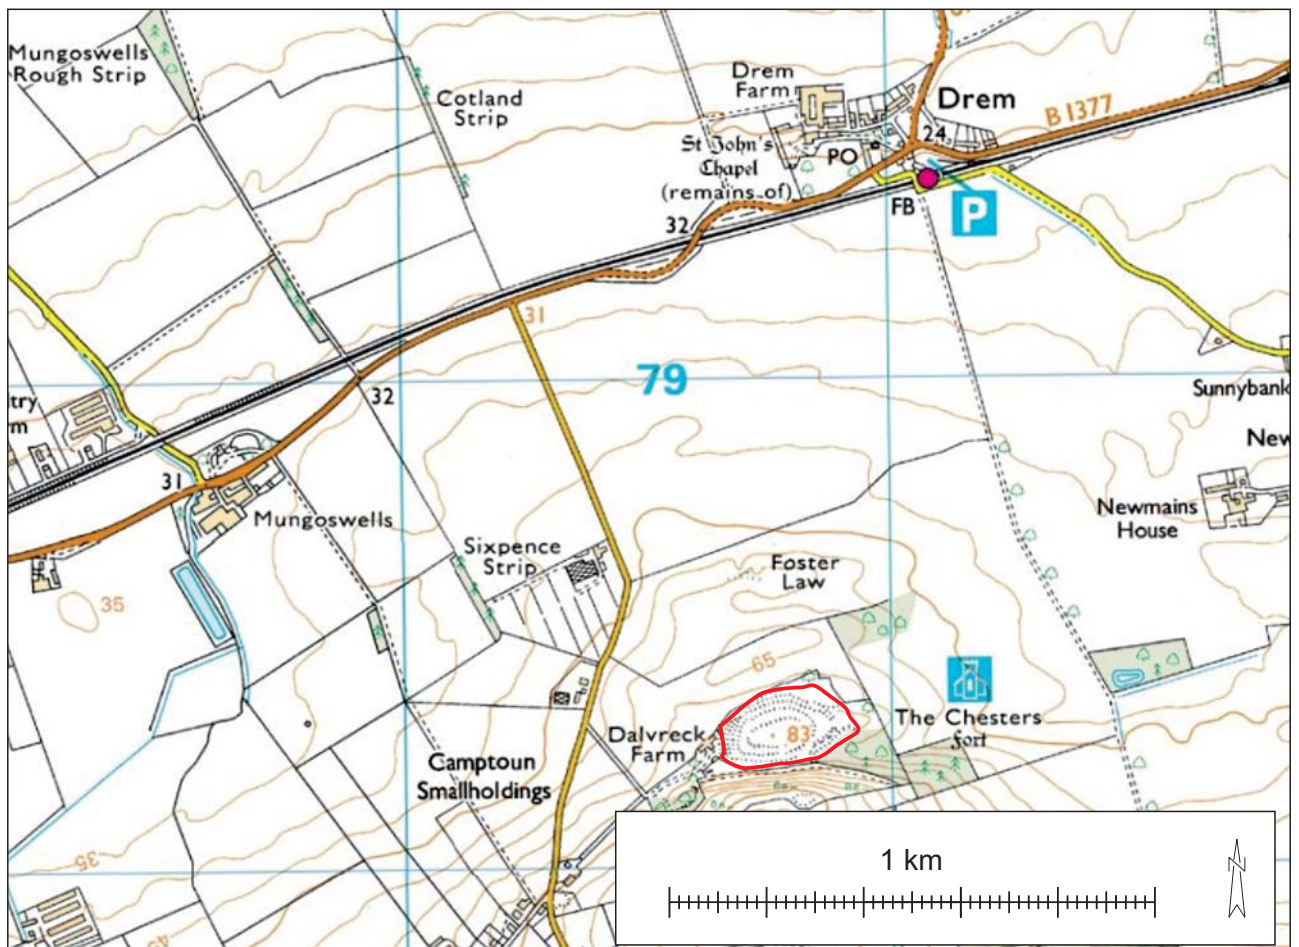
Erosion survey

- 5.1 The erosion survey methodology was based upon that developed by the CFA, as outlined by in Historic Scotland's Technical Advice Note 16: *Burrowing Animal and Archaeology* (Dunwell & Trout 1999). The survey recorded visitor tracks, stock tracks, gorse damage and rabbit burrows. (Figure 2)
