MONUMENT	DUMBARTON CASTLE
PROJECT	Masonry Repairs at Governor's House

PROJECT DRAWING NUMBER	North Elevation Proposals	
SCALE	NTS	ARCHITECT I Lambie
DATE	June 2016	DRAWN BY S Bain
ARCHIVE NUMBER	193-107-536

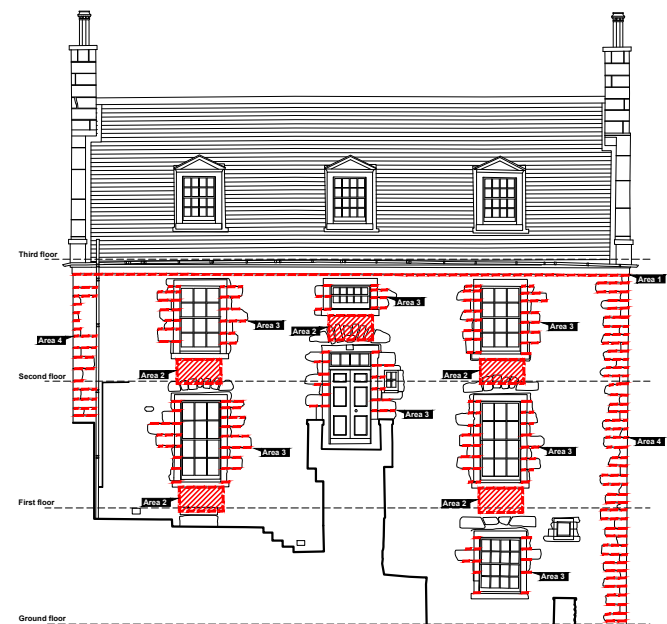
NORTH ELEVATION

Location of the masonry requiring repair
north elevation

Description of the masonry requiring repair
original buff sandstone and grey whinstone rubble units, pointed with non-original cementitious mortar

Condition of the masonry requiring repair
the non-original cementitious mortar pointing at joints between masonry units is decayed in places, ie loose, cracked, missing etc

Proposals for the masonry requiring repair
rake out areas of decayed non-original cementitious mortar pointing and replace with new lime mortar pointing at areas shown adjacent, as follows...

Schedule of masonry repairs
carefully rake out mortar joints to remove decayed cementitious mortar pointing from walls

new building and pointing mortar mix to be 2 parts Otterbein NHL5 hydraulic lime to 5 parts Cambusmore sand, by weight
