MONUMENT	ARGYLL'S LODGING
PROJECT	Corridor 2.05 and Room 2.07
Repairs to lower tie and rafter of roof truss-Methodology

PROJECT DRAWING NUMBER		PIC107-2021-CE-18A	
SCALE	As shown @ A3	Engineer	F Nanopoulou
DATE	13/10/2021	DRAWN BY	FN
ARCHIVE NUMBER

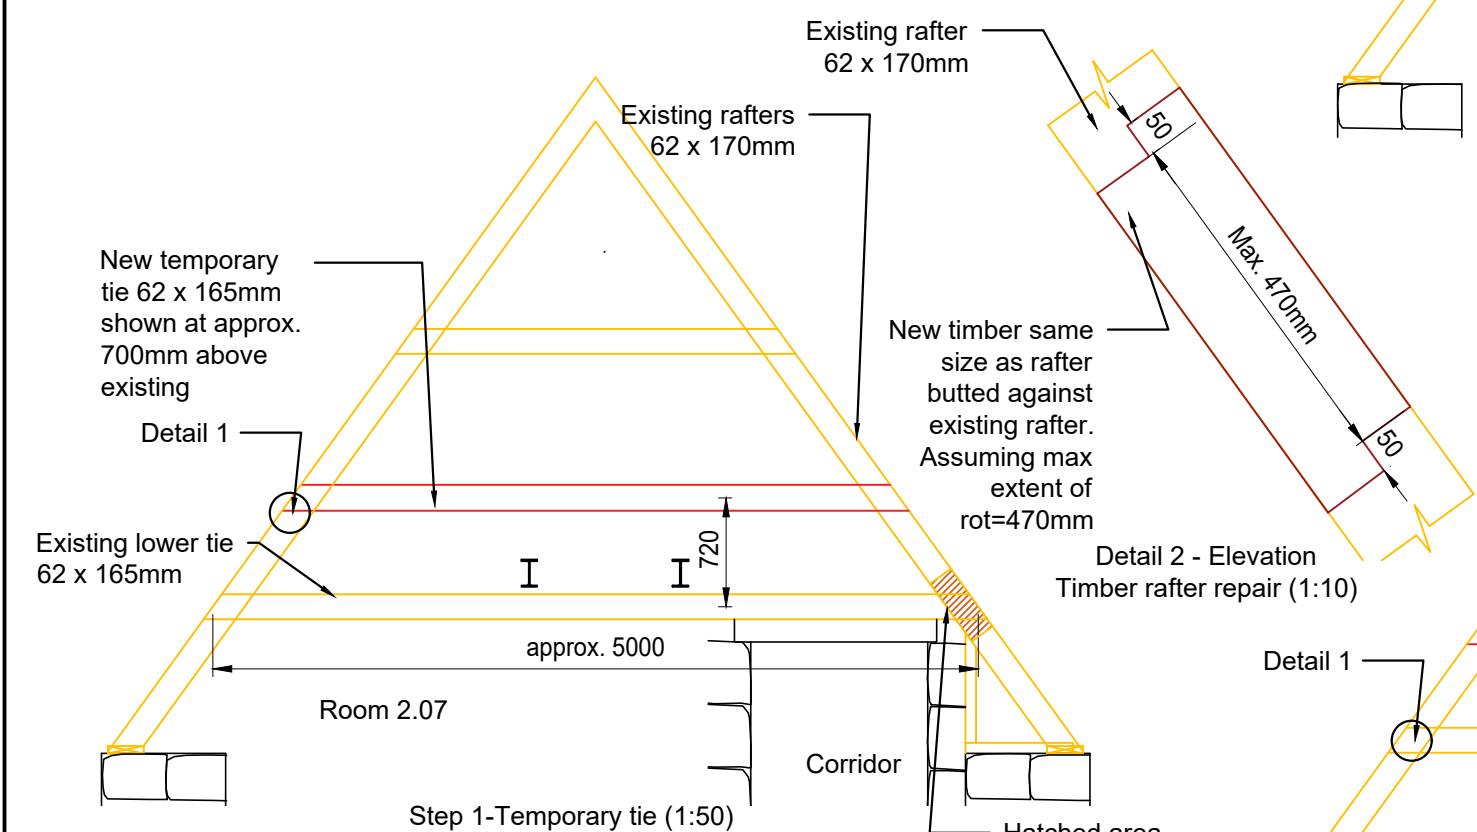
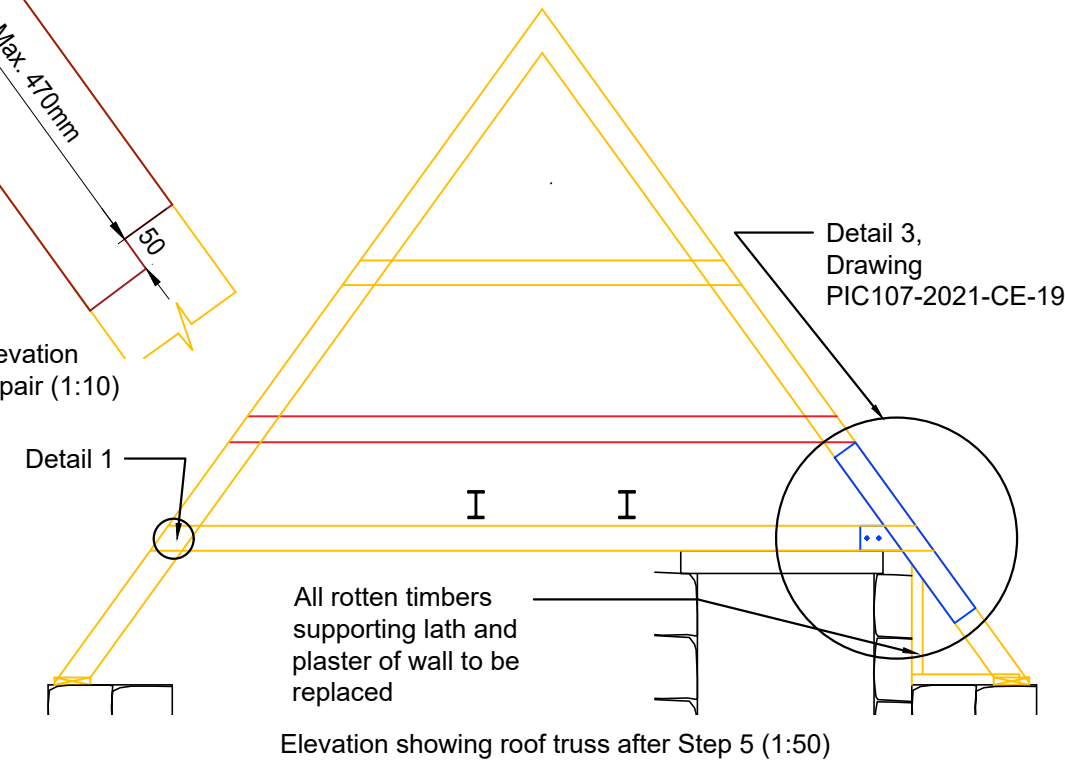
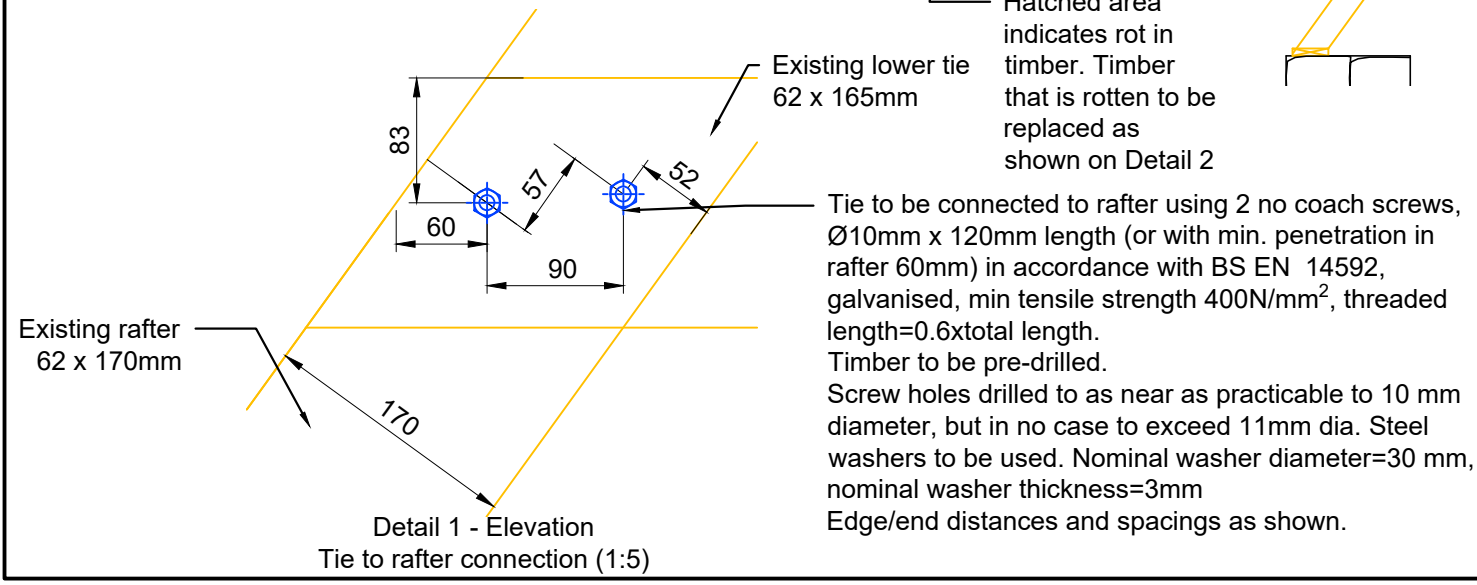
2. Existing tie to be removed as a whole and set aside. Tie to be examined for signs of rot at its ends. Ceiling is probably supported off tie in Room 2.07. To be ascertained if this is the case as plaster ceiling will have to be locally removed to allow for tie removal

3. Rotten part of rafter to be removed and new timber piece to be installed butted against existing and notched in as in Detail 2. Prop rafter on each side of the rotten timber prior to removing it. Props to continue to first floor level (Similar propping arrangement as for lintels replacement-Drawing PIC107-2022-CE-21)

- Methodology**
1. New temporary tie 62x165mm to be installed above existing (approx. 600mm above) as shown with red dashed lines. Connection of tie to rafter as per Detail 1

4. New splice steel plates to be installed along rafter as shown in Detail 3 on sound timber. Ensure centre of new bolts to be at least 100mm from end of rotten timber section of rafter

5. If timber tie is in good condition with no signs of rot, to be re-instated and connected to rafter on RHS as per Detail 5 and to LHS as per Detail 1. If timber is rotten at ends, replace it with same size timber Grade C24

6. Temporary tie can be removed
