Lion's Den Lintols, Striling Castle

Archaeological Monitoring & Dendrochronological Assessment Survey

Written Scheme of Investigation

AOC 26813-59

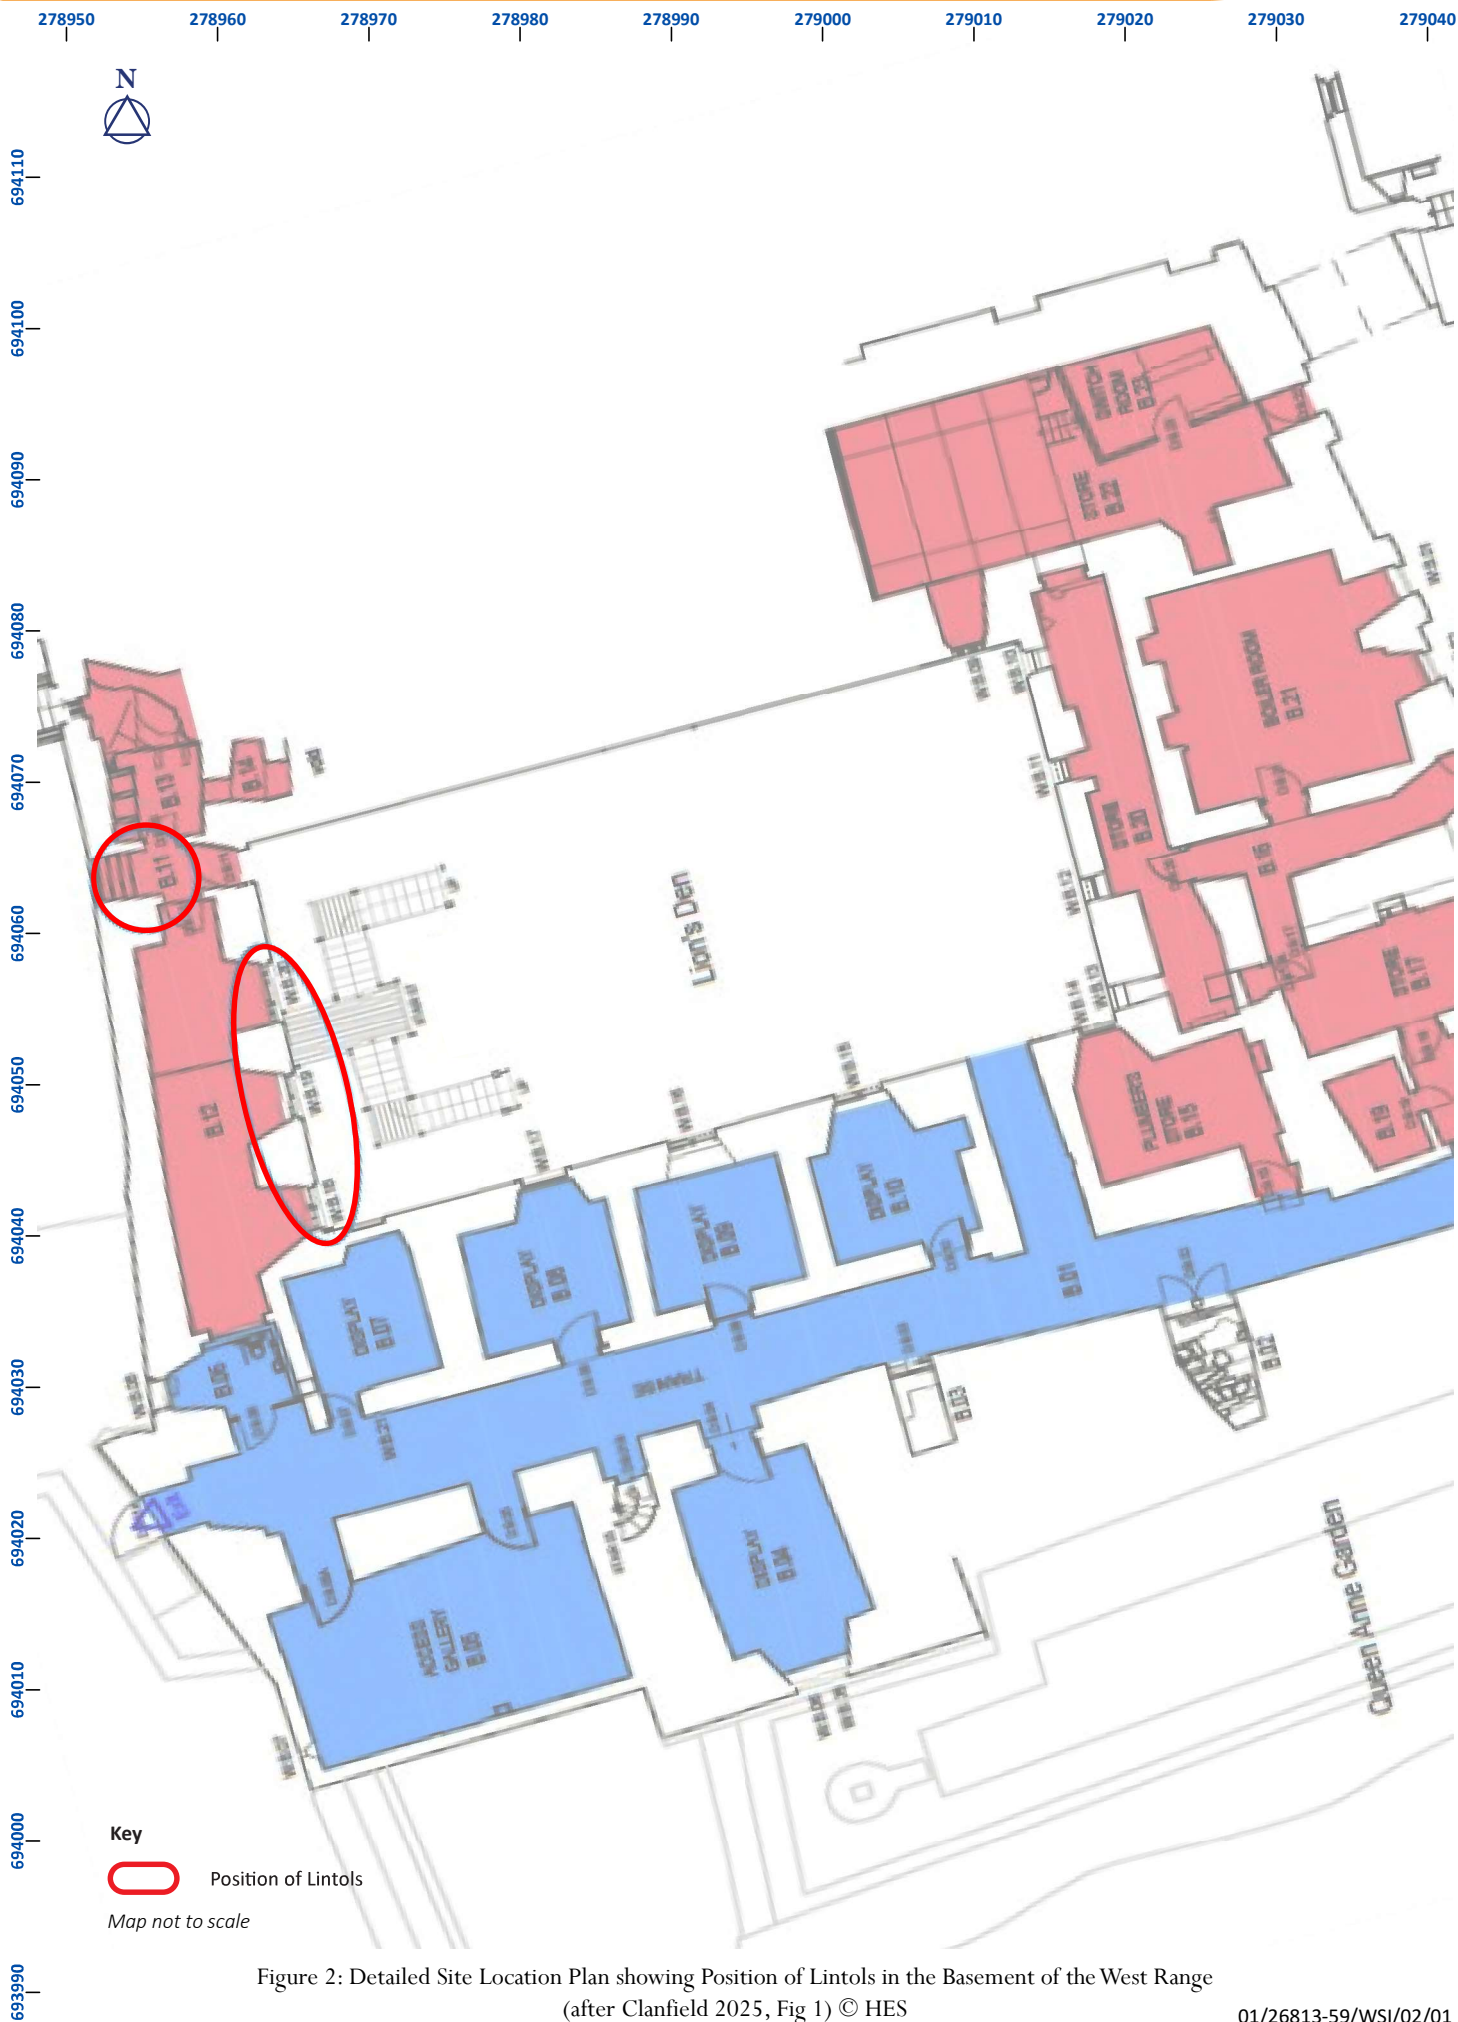
- 1.1.3 In the west range of the Palace, at vault level, timber lintols in four locations have been identified as requiring replacement, as decay means they no longer have structural integrity. Figure 2 outlines the exact position of each of these lintols, and the areas are presently blocked off and lintols propped up to avoid loading.

Figure 2: Detailed Site Location Plan showing Position of Lintols in the Basement of the West Range (after Clanfield 2025, Fig 1) © HES

- 1.1.4 It is the intention to remove these lintols and replace them with concrete lintols. In addition, the lintel of opening W:B.19 in Room B12 has a vertical crack in the centre requiring the insertion of a 10mm thick bronze bar in the mortar joint below the lintel, with 150mm bearing on either side.

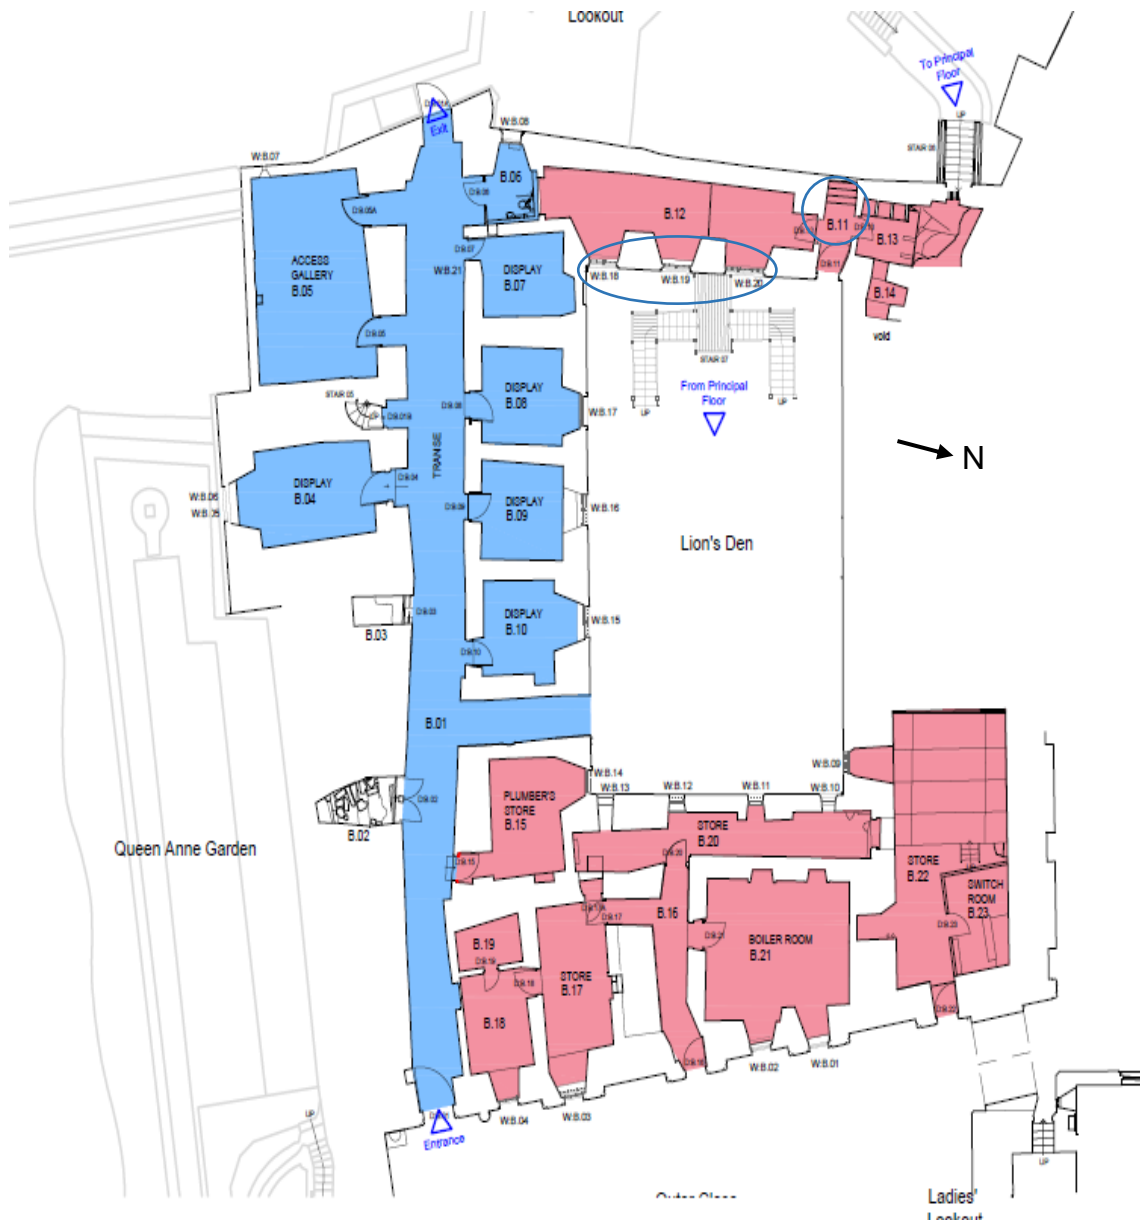
In the West range of the Palace, at vault level, wooden lintols in four locations have been identified as requiring replacement, as decay has led to them having no structural integrity, and there is a short bearing at the ends. The timber lintols above the steps in area B.11 (Fig 1) are bowing and have significant rot (Fig 2), and the lintols above the windows W:B.18, W:B.19 and W:B.20 in B.12 are also deteriorated (Fig 3).

Fig 1. Plan of the vault level of the buildings surrounding the Lion's Den. The timber lintols are within B.11, at the west end of the room, and above windows W:B.18, W:B.19 and W:B.20 in B.12.

The lintols have been propped and the area above barriered off to avoid loading. Removal of the decayed lintols and replacement with concrete lintols has been proposed. The extent of these repair works means the age and significance of the timbers and surrounding masonry need to be taken into consideration.

In addition, the external stone lintol to W:B.19 has a vertical crack in the centre (Fig 4). The proposed repair is the insertion of a 10mm thick bronze bar in the mortar joint below the lintol, with 150mm bearing on either side.

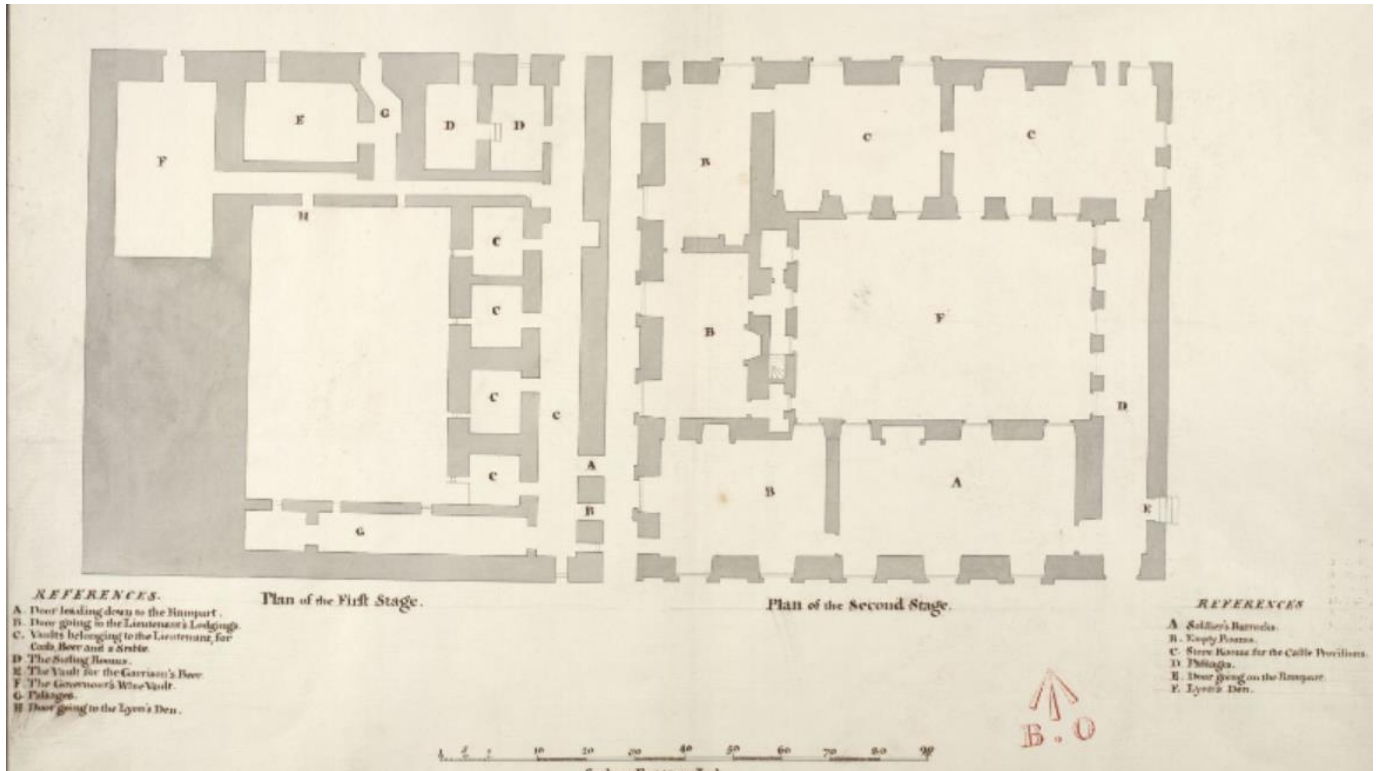
Plans of area B.11 and B.12 in 1741 (labelled G in Fig 5) show three small openings along the wall where there are now four openings: W:B.18, 19, and 20 and a doorway. The windows in the plan are significantly smaller than the present openings and are likely to be closer in size and plan to the original 16th century structure.

Fig 5. This plan from 1741 shows only three small opening in the wall where the windows now are (G – Passages, in the left-hand plan). The windows were widened after 1741 and the lintols probably put in to support this. Reproduced with kind permission of the trustees of the National Library of Scotland (<https://maps.nls.uk/view/00002707>)

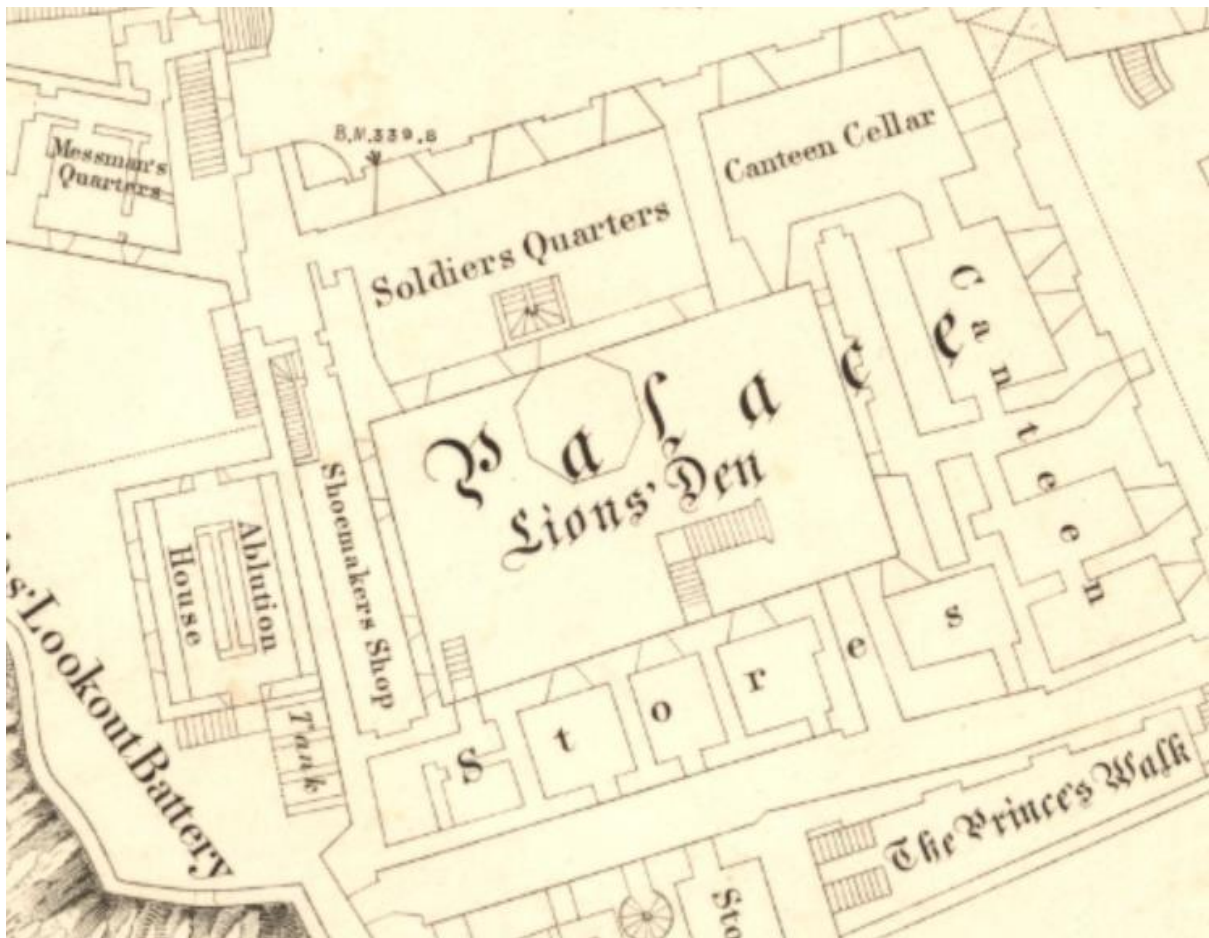
The OS map of 1858 (Fig 6) shows a different arrangement of openings off the Lion's Den to both the current arrangement and the 1740s arrangement shown above. In comparison to the modern plans, both of these historic plans show much narrower openings than the present windows and that the window splays internally are a different width and different angle to those at present, clearly demonstrating that the window openings have been remodelled. If both the 1741 and 1858 plans are accurate, this suggests at least three different arrangements of windows here between the early 18th century and today.

Fig 6. OS map, surveyed 1858. This shows a different arrangement of openings off Lion's Den to the current arrangement and the 1741 arrangement. Reproduced with kind permission of the trustees of the National Library of Scotland (<https://maps.nls.uk/view/74416799>)

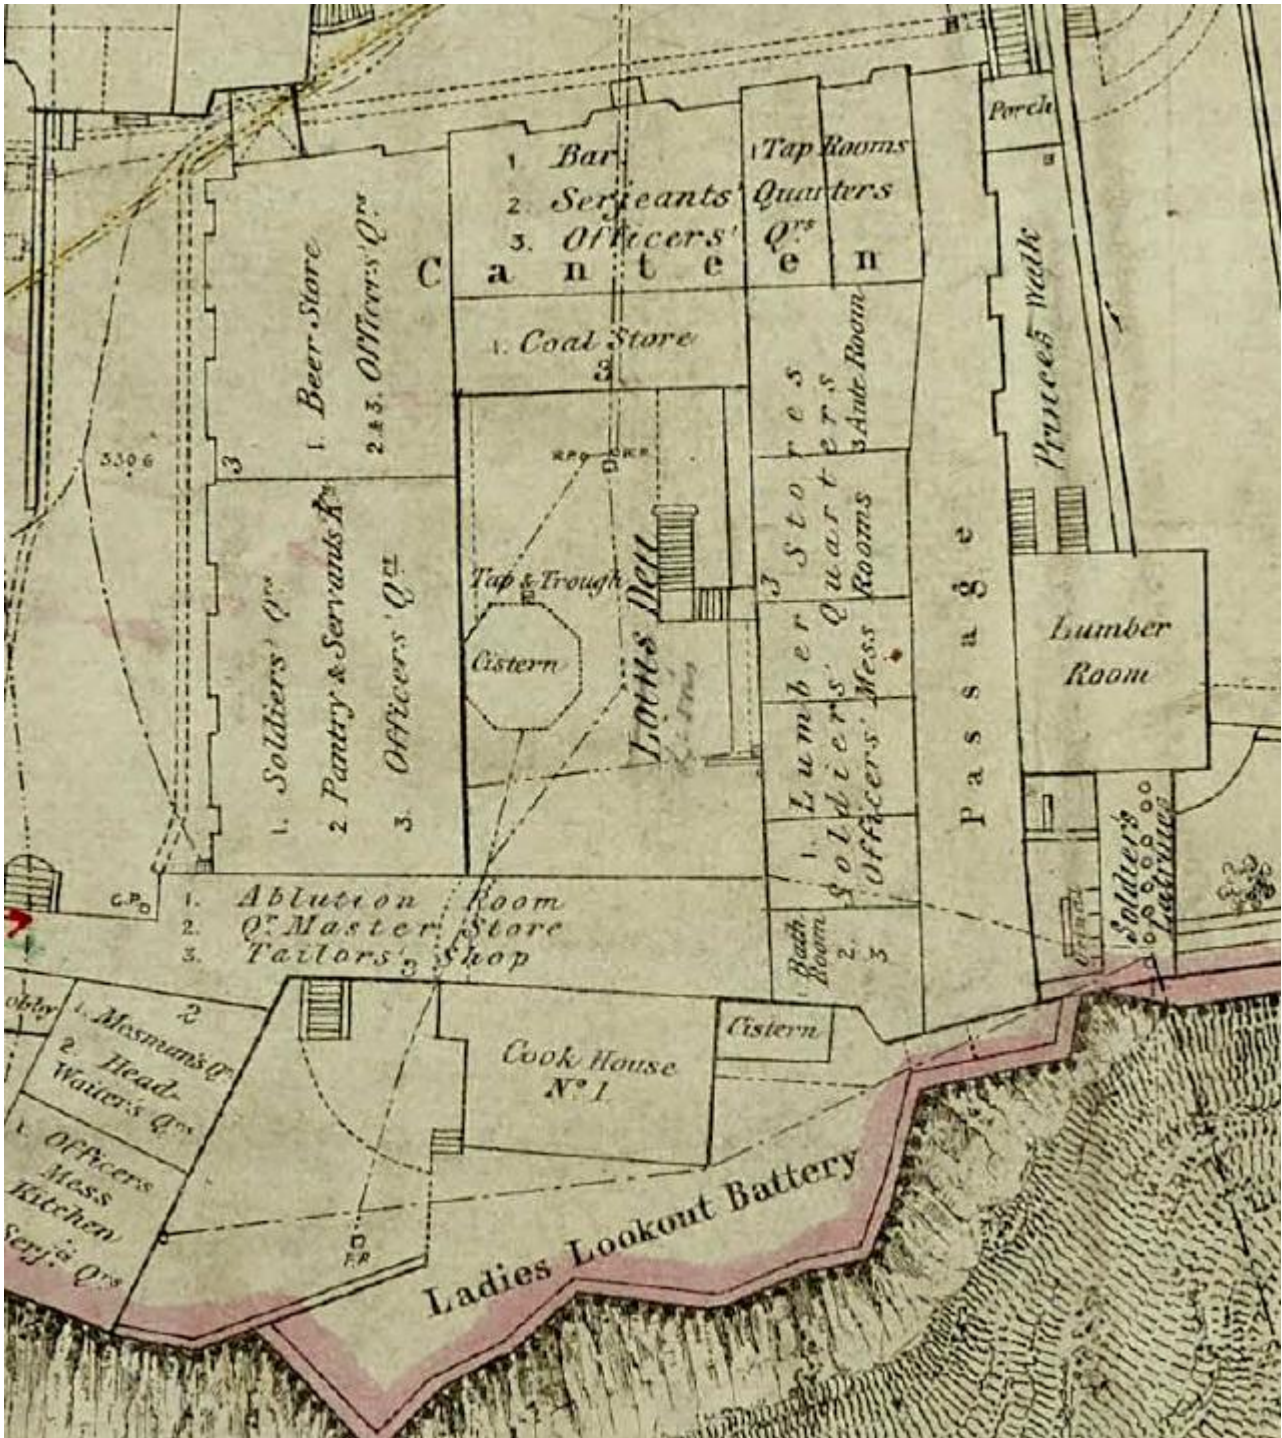
A cookhouse was added to the West side of the building before 1814, with an extension, possibly a staircase, added by 1847. In 1854 the building was converted to an ablution house and a rectangular water tank was mounted on a stone footing to the south of the ablution house, which is visible in the War Office plan of the castle from 1866 (Fig 7). Alterations including addition of doorways to accommodate access were made around the time of this conversion, which may have included the alterations to the windows and structure of the vaults. The building was converted back to a cookhouse in 1900, and a small porch on the north side linked it with the palace vaults. It was demolished in 1970.

Fig 7. The War Office plan of Stirling Castle, surveyed in 1866, shows the building on the side of the West range added by the military for use as a cookhouse and later an ablutions house (HES archive)

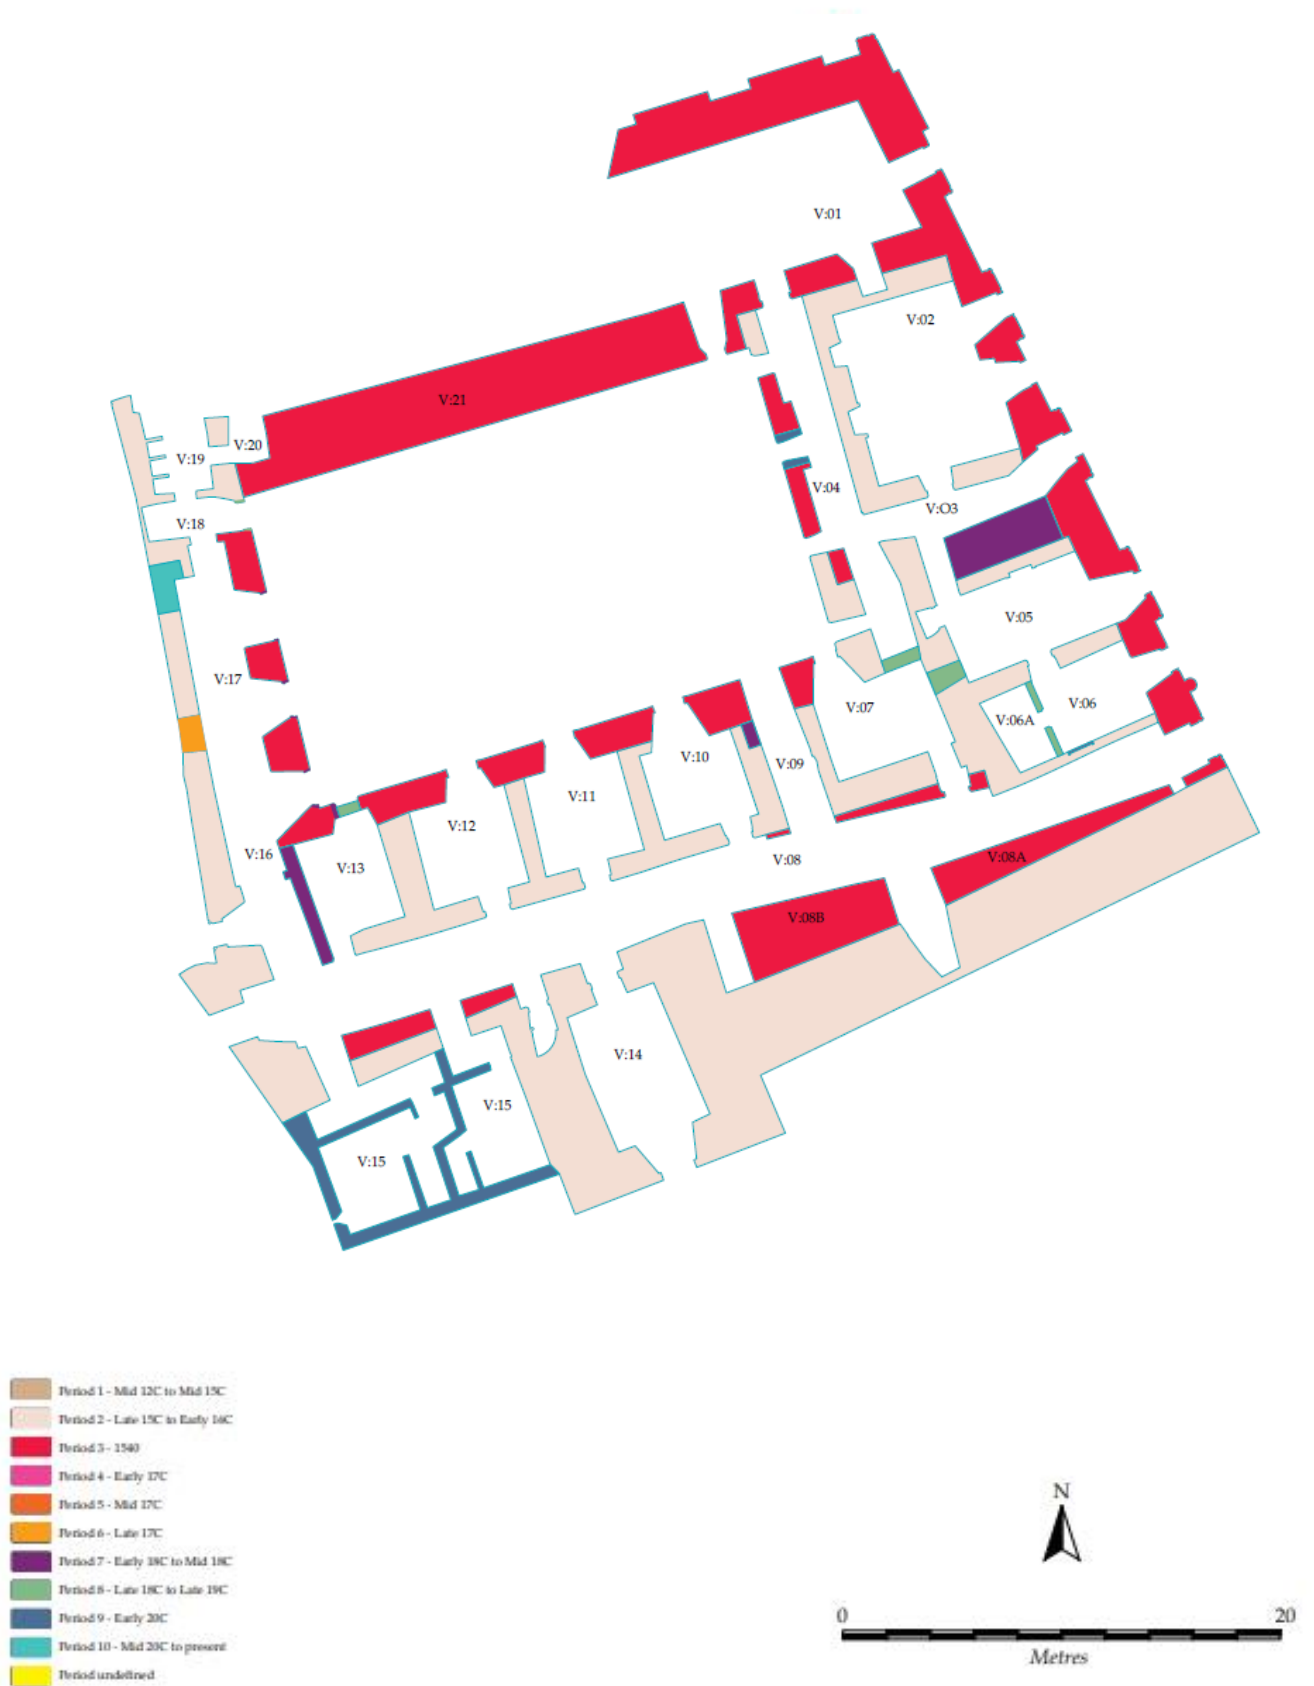
Interior and exterior elevations were recorded in detail at this time. This investigation found that the windows in B.12 were widened in the early- to mid- 18th century, and the ceiling in B.11 was raised and reconstructed with wooden planks (Ewart, Murray and Hogg 2008: p50).

Fig 8. Phases of the building fabric, Ewart and Gallagher 2015: p64. V:17 and V:18 are areas B.11 and B.12 respectively. This does not seem to fully represent the complexity of the phases of alterations which have recently been identified in the vaults.
