Holyrood Abbey

Abbey Crossing: Bench Installation

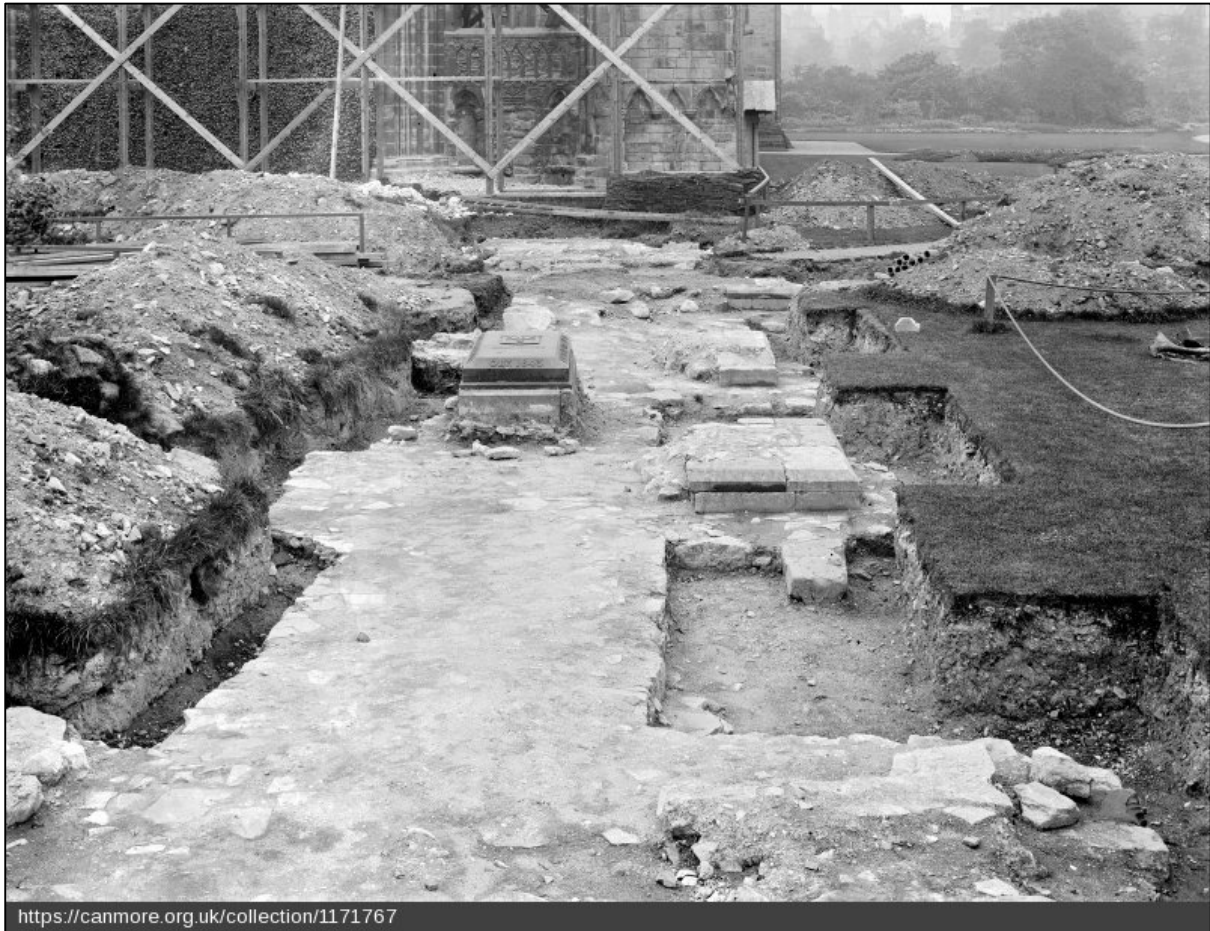
Figure 4: Image showing remains encountered during Ministry of Works excavations, note wooden scaffolding in front of Abbey east wall (facing west)

Previous archaeological work has been carried out in the vicinity of the proposed bench location. It is unclear whether the investigations carried out by the Ministry of Works in the early 20th century targeted the area to the west of the modern path through the crossing. An image held in the HES Collections (SC 1171767³) (Figure 4) indicates that at some point during the investigations the proposed location was covered in wooden scaffolding and therefore may not have been investigated.
