MONUMENT	Invercauld Bridge
PROJECT	River Bank Reinstatement Slope protection detail

PROJECT DRAWING NUMBER	EDS.4.1.29/04	
SCALE	as shown @ A3	Engineer Kashif Ashraf
DATE	19.07.2016	DRAWN BY KA
ARCHIVE NUMBER

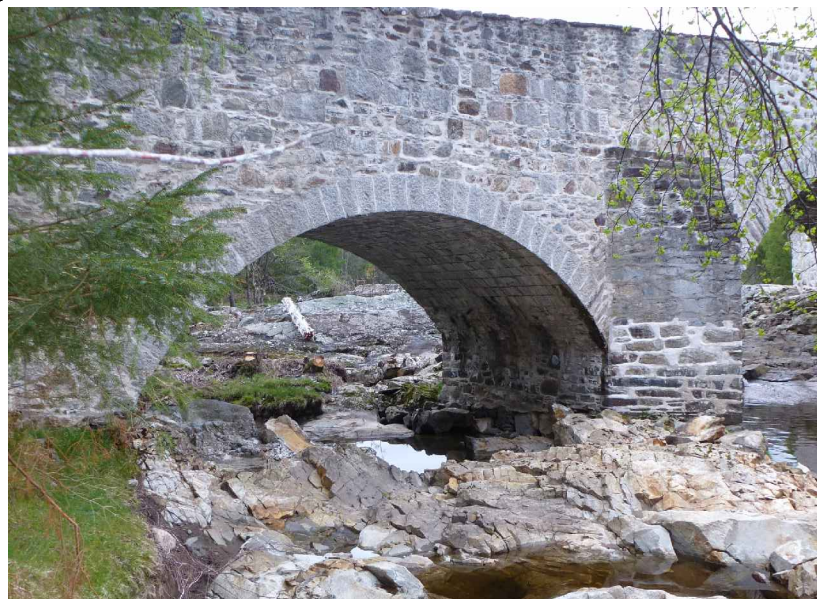
Photo showing current bank condition (NTS)

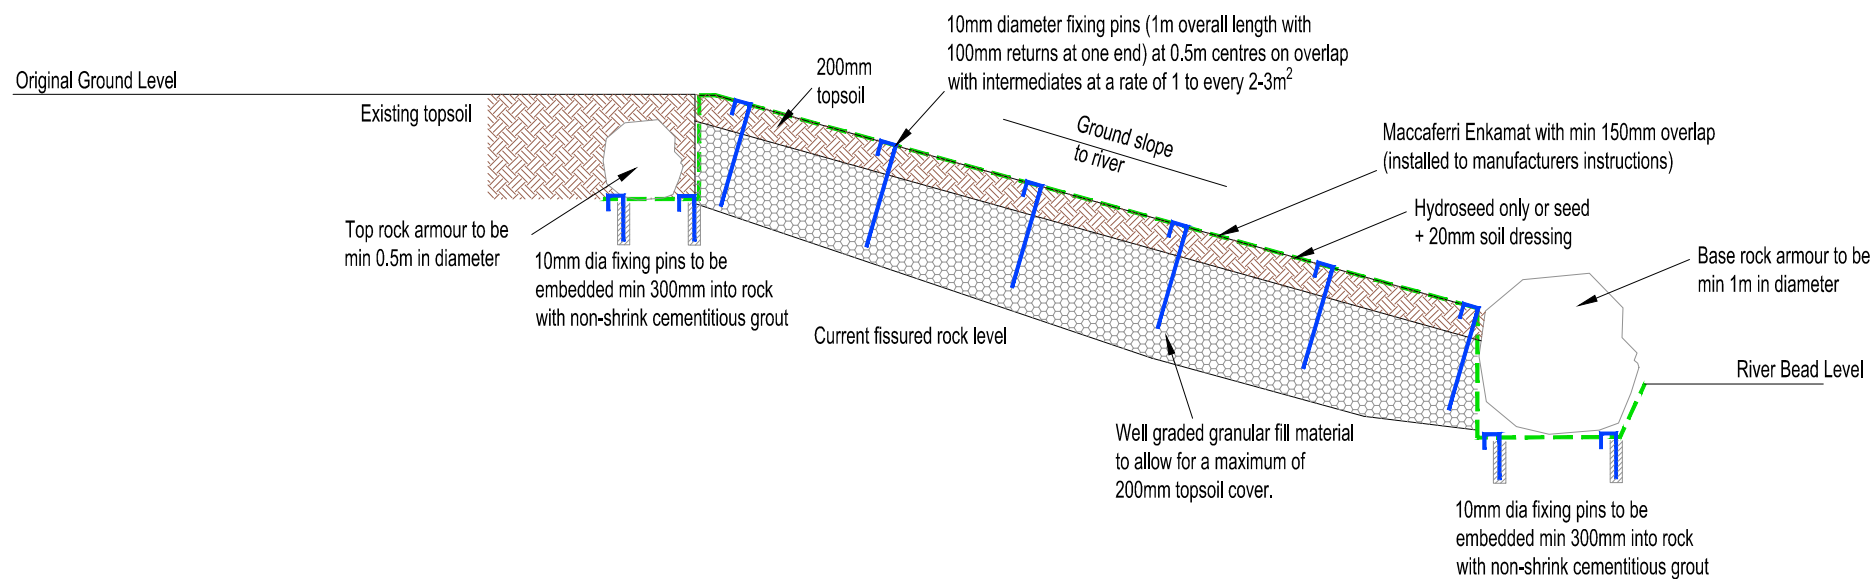
Section Through Proposed Bank Reinstatement (1:50)

- Notes:
- Extent of bank reinstatement to be determined on site by contractor
 - Local variation to detail is acceptable and must be recorded and notification sent to Architect / Engineer
 - All concrete and grout works to be carried out under controlled conditions to prevent any contaminants from seeping into river
 - SEPA to be notified immediately if contaminants are found to have entered the river
