## **Union Canal, Slateford Aqueduct, Edinburgh and Avon aqueduct, Linlithgow, West**

### **Canal Channel Leakage Arrest**

**September 2016**

## **Methodology**

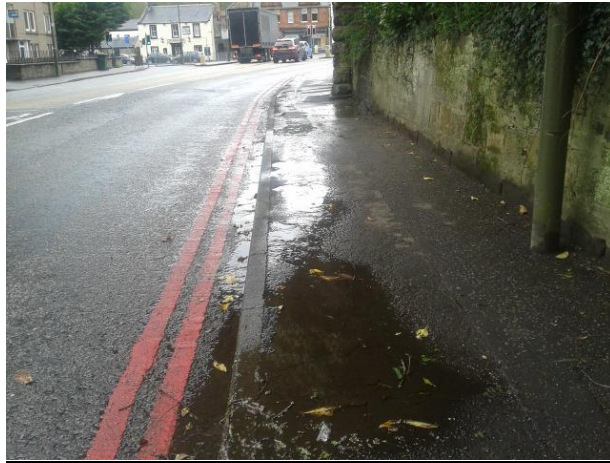
Slateford aqueduct canal leakage at footpath and road level

Leakage has been detected at both aqueduct locations. The leakage at Slateford is causing public nuisance and public risk by wetting the public footpath ( Fig 1). The leakage is confined to the west side of the aqueduct.

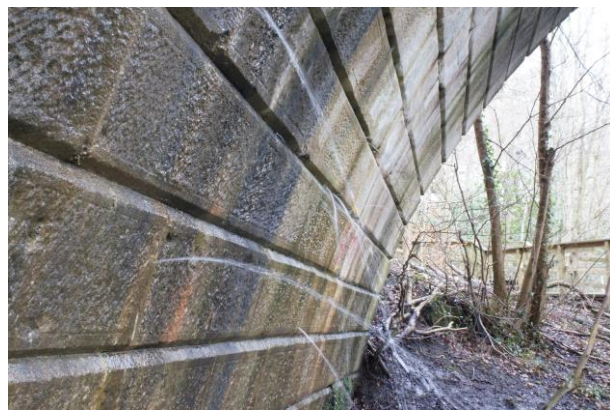
Avon aqueduct showing leakage exiting structure under pressure

Avon is also leaking at the same location, west end but is not causing public nuisance but will continue to deteriorate the structure and monument.

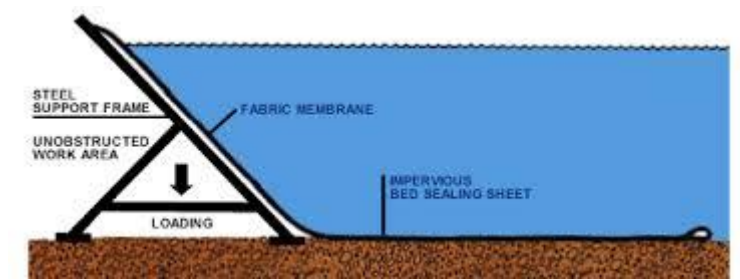
Temporary fabric dam

Temporary localised dewatering to include for damming using fabric dams or similar approved. Material e.g. clay for temporary dam construction will not be permitted due to access constraints.

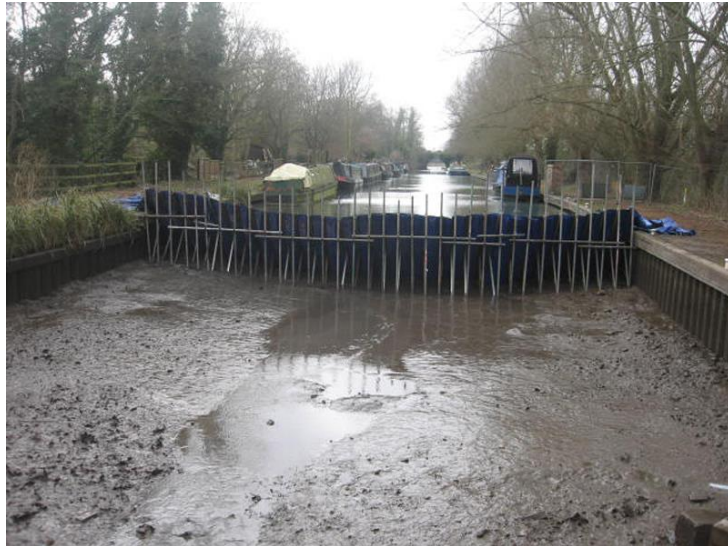
Fabric dam deployed in canal channel
