Fig 3: location of proposed tests

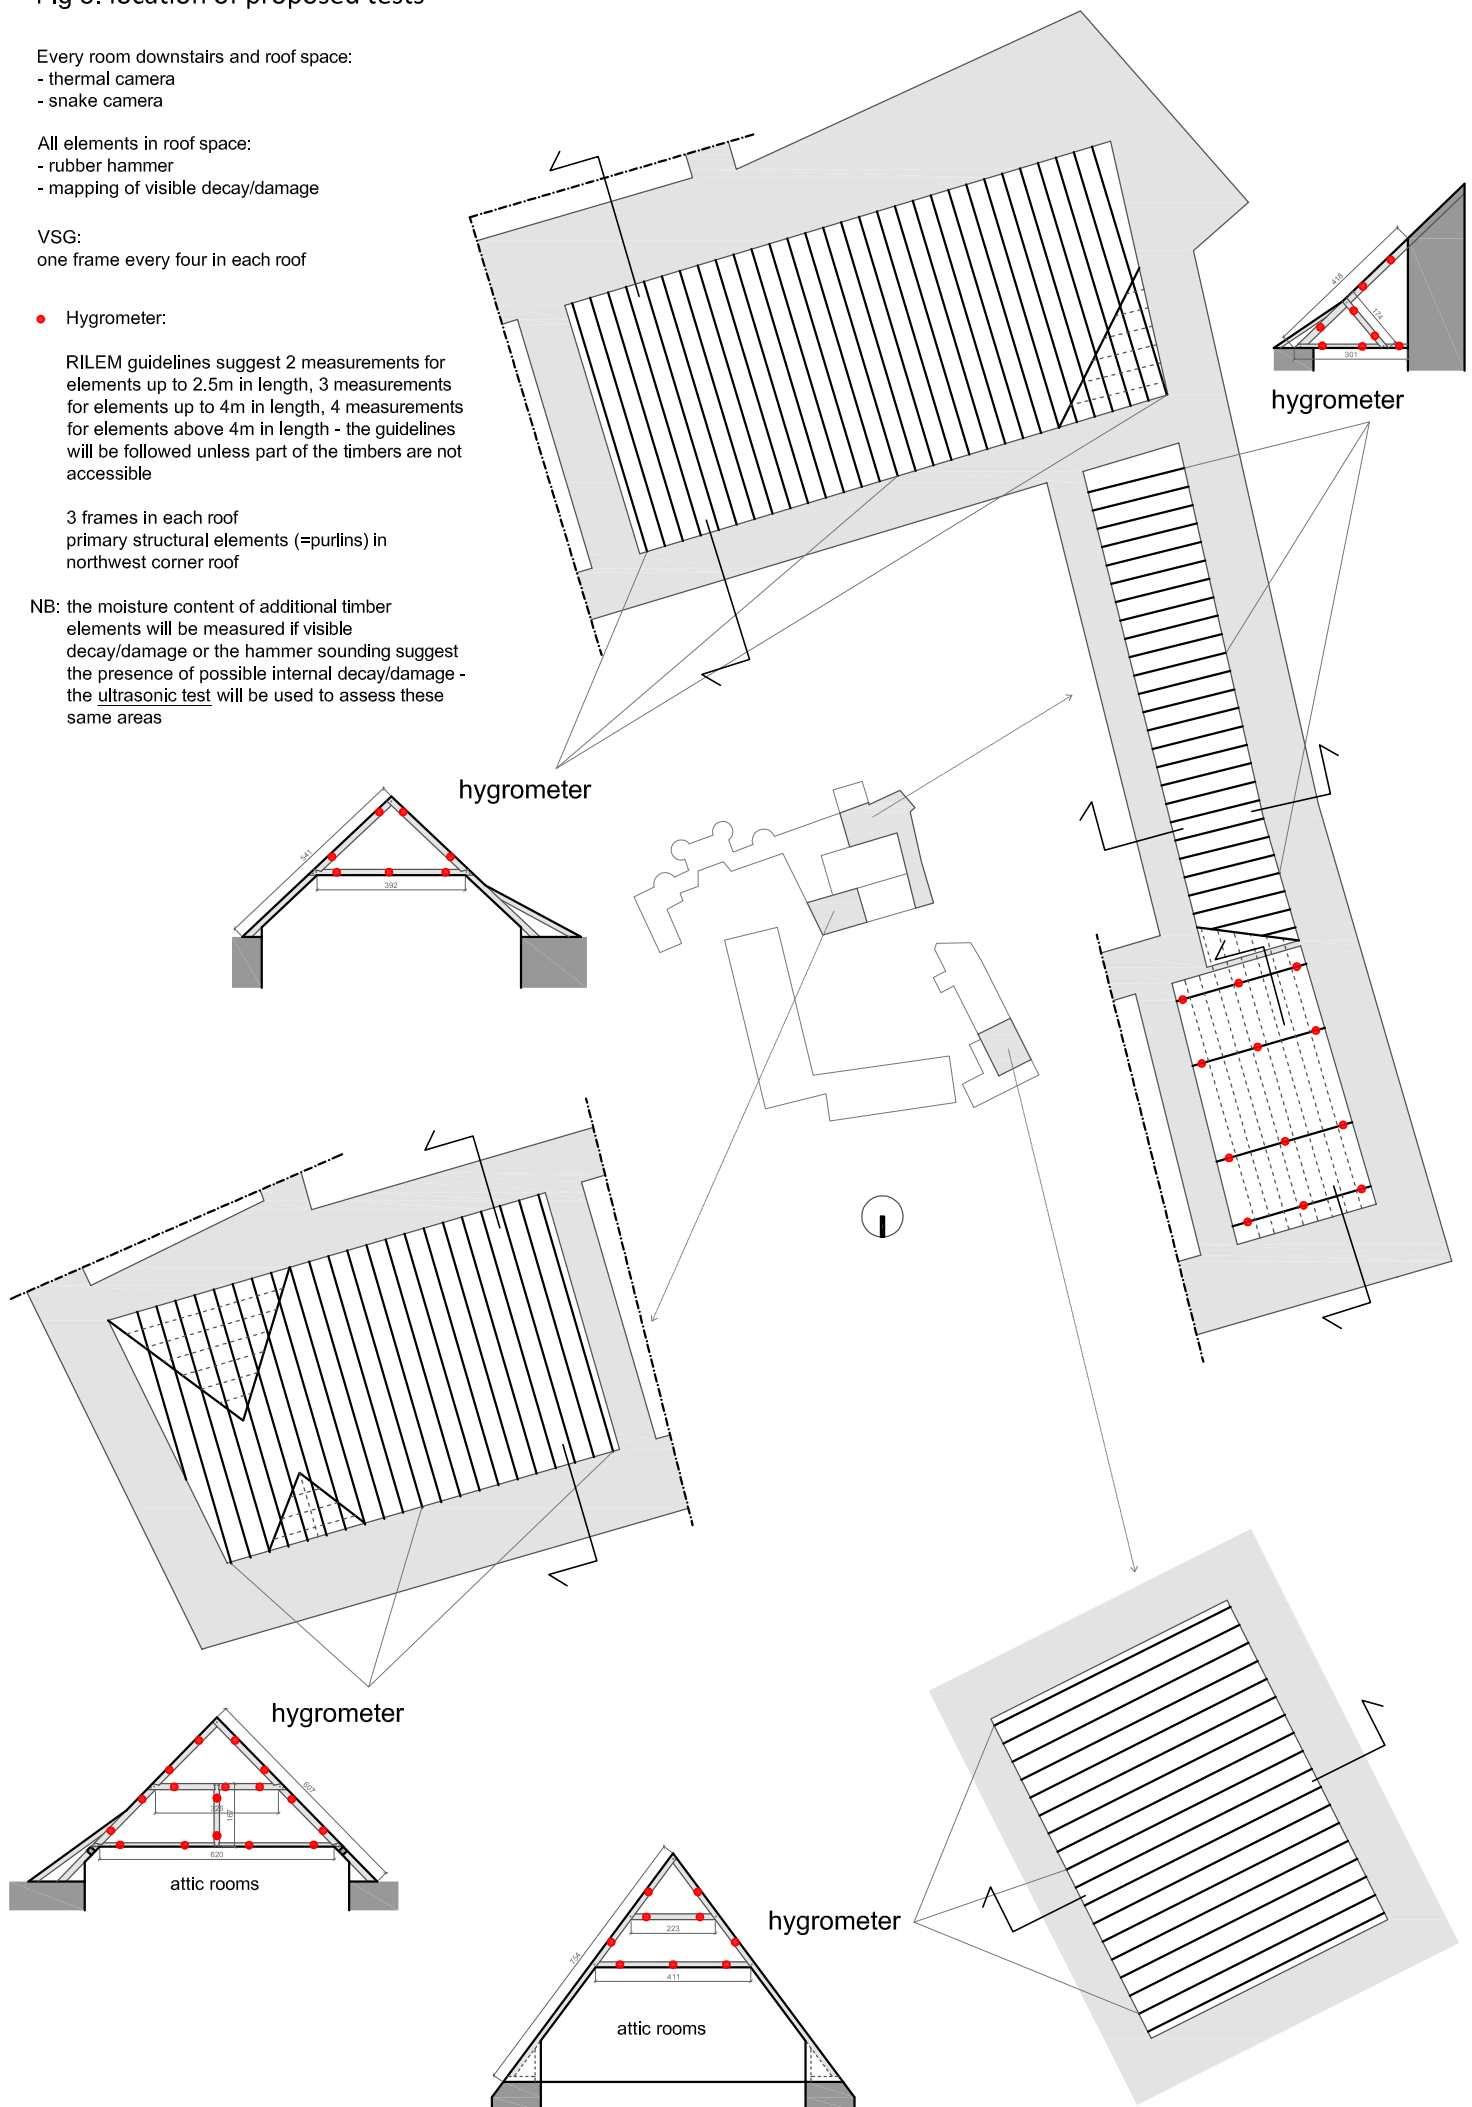
Every room downstairs and roof space:

- thermal camera
- snake camera

All elements in roof space:

- rubber hammer
- mapping of visible decay/damage

VSG:

one frame every four in each roof

• Hygrometer:

RILEM guidelines suggest 2 measurements for elements up to 2.5m in length, 3 measurements for elements up to 4m in length, 4 measurements for elements above 4m in length - the guidelines will be followed unless part of the timbers are not accessible

3 frames in each roof
primary structural elements (=purlins) in
northwest corner roof

NB: the moisture content of additional timber elements will be measured if visible decay/damage or the hammer sounding suggest the presence of possible internal decay/damage - the ultrasonic test will be used to assess these same areas
