Burghead well – fit additioanl rope handrail

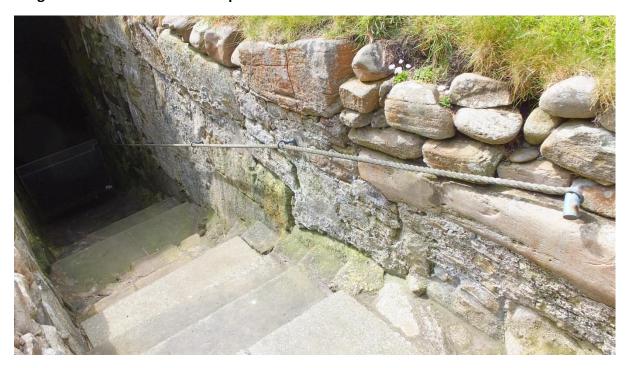
Existing handrail has 6no. anchors into masonry or concrete in joints.

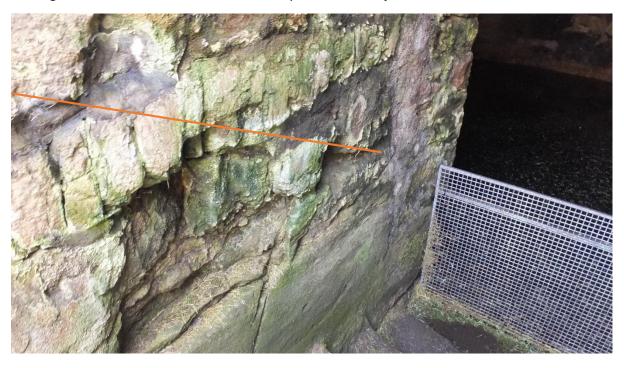
Proposed base fixing for rail in concrete adjacent to grill

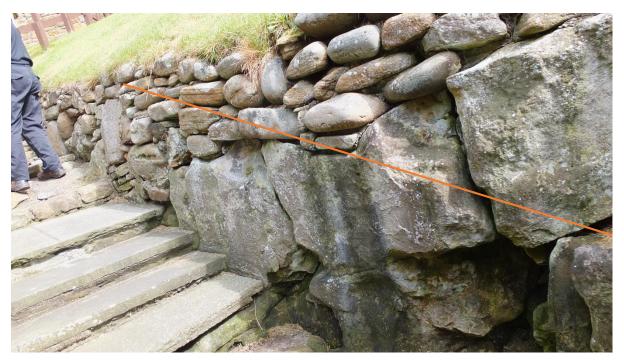
Modern rubble build to be locally rebuilt with cement mortar core where fixing required. Rope handrail.
