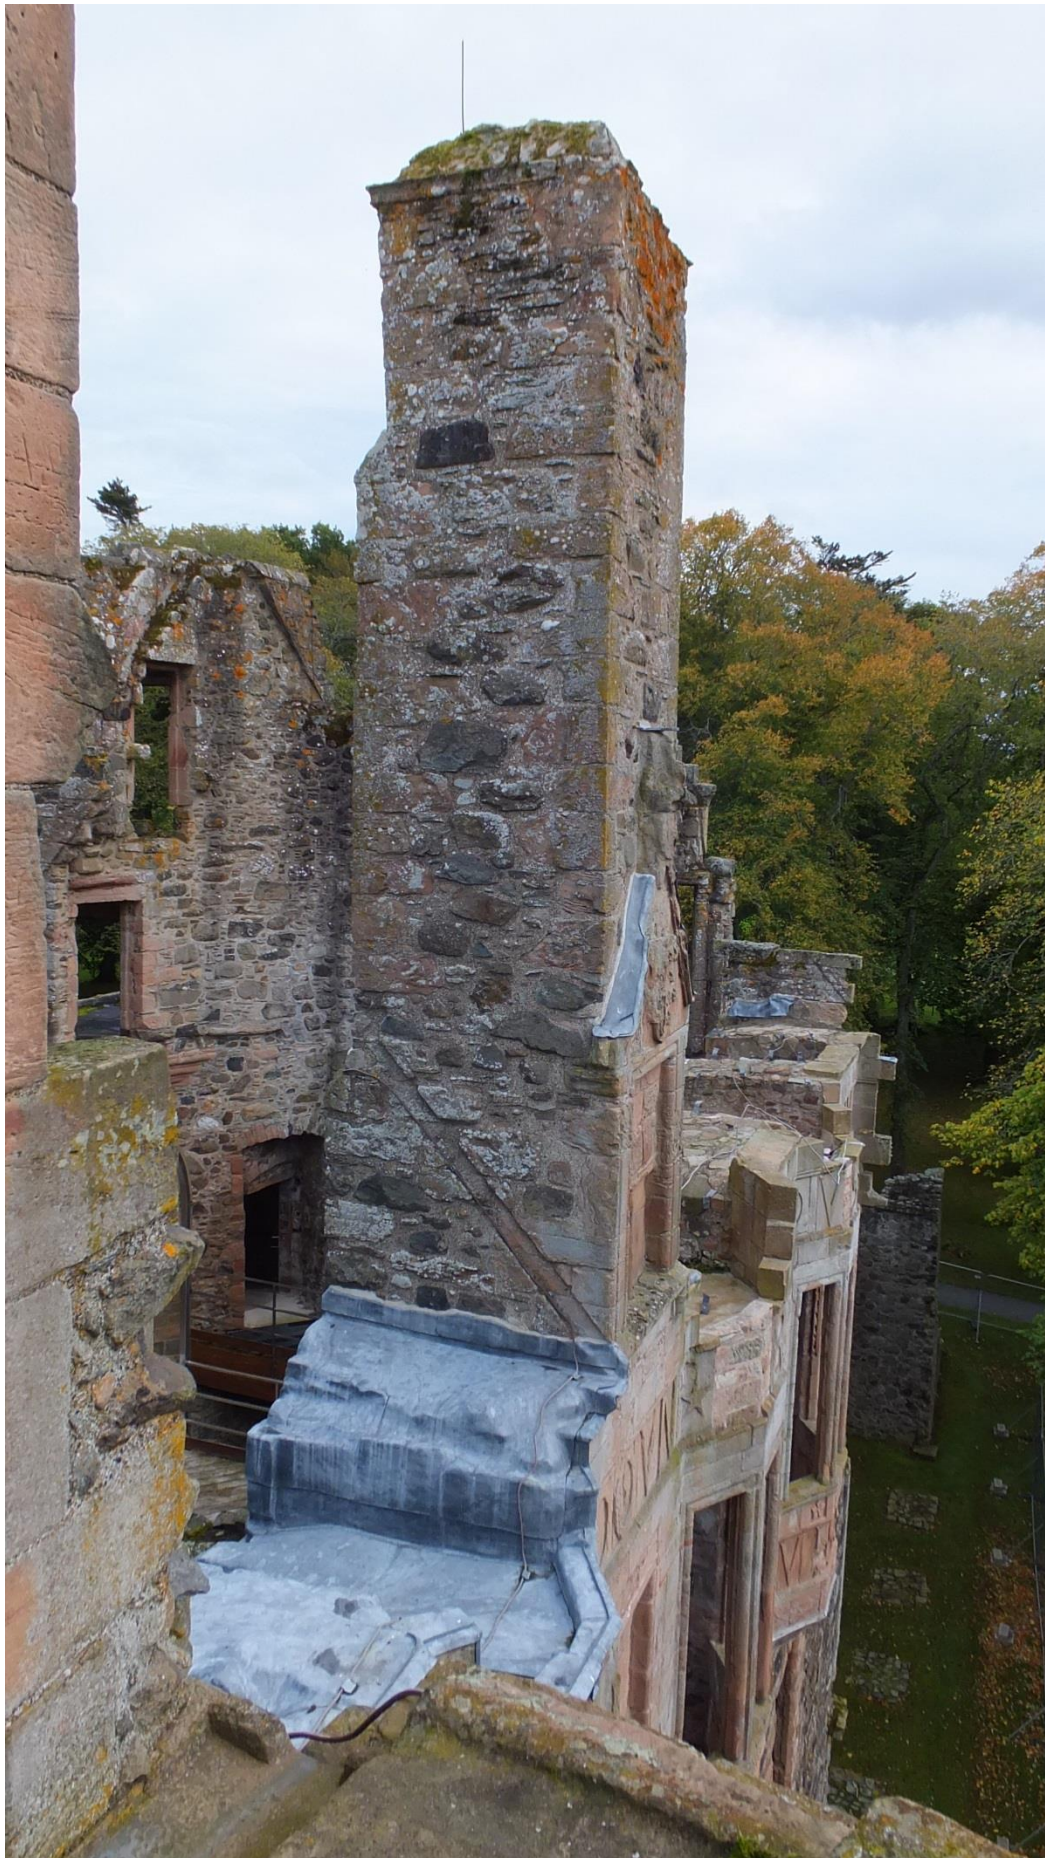
Typical view of wallhead form round tower. Ashlar to front elevation and flashings/drip to interior to be in lead as in previously built scheme (see extract from original drawings).

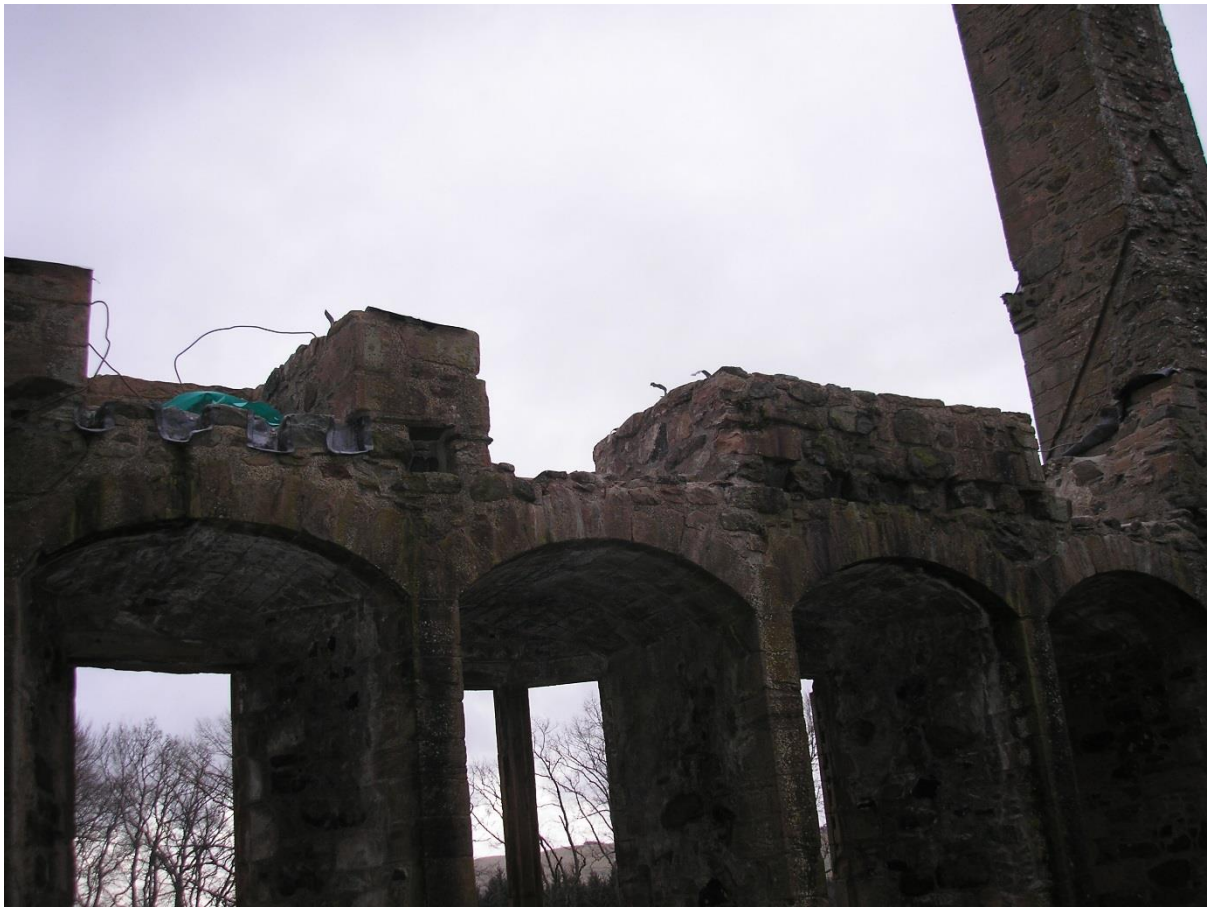
Typical view of section of interior where lead stolen (some pocket flashings remain – to be reinstated).
