Spynie Palace: The Bishop's Well

Archaeological investigation of the well and surrounding features

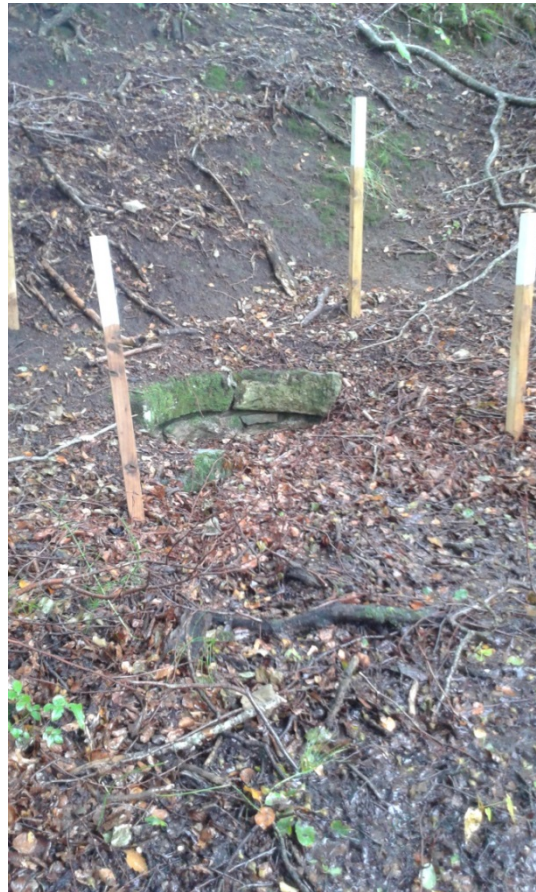
The Bishop's Well

The requirement for some sort of barrier or cover to prevent access to the well is hard to dispute. Choked with leaves and hard to see, it is an obvious health and safety hazard. The well is on sloping ground, not visible from the shop, and most people would approach it from the road above, which increases the risk of an accident. This significance of the well, and therefore the impact of any intervention is currently unknown. It is potentially associated with the palace, or nearby settlement, although no interpretation is provided for it at present. Therefore, the potential benefits of undertaking investigations at the well are:

The least invasive solution to the health and safety risk posed by the well is to cap it, if this is possible. Therefore we recommend that option 1 is enacted in the first instance. If the state of the well is such that it is not possible to achieve this, option (2) should be adopted. This will allow us to explore the extent of the features around the well and so whether it might be possible to fence off the well without impacting on these features. If the extent of the features around the well is such that positioning the fence off of them is clearly impossible, option (3) should be considered in order to better understand the significance of the features and so assess the impact of partial loss in order to make the area safe.

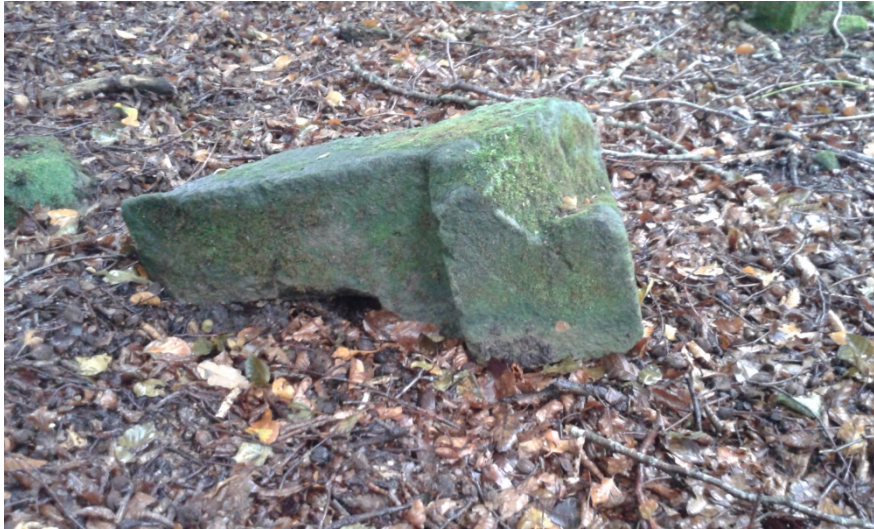
The least invasive solution is to cap the well. Whether or not this is possible will depend on the structural integrity of the well, which will require further investigation of the feature and its immediate surroundings. It is possible that the northern part of the well has been lost. There are some detached stones downhill from the well which may have come from it.

Detached stonework near the well

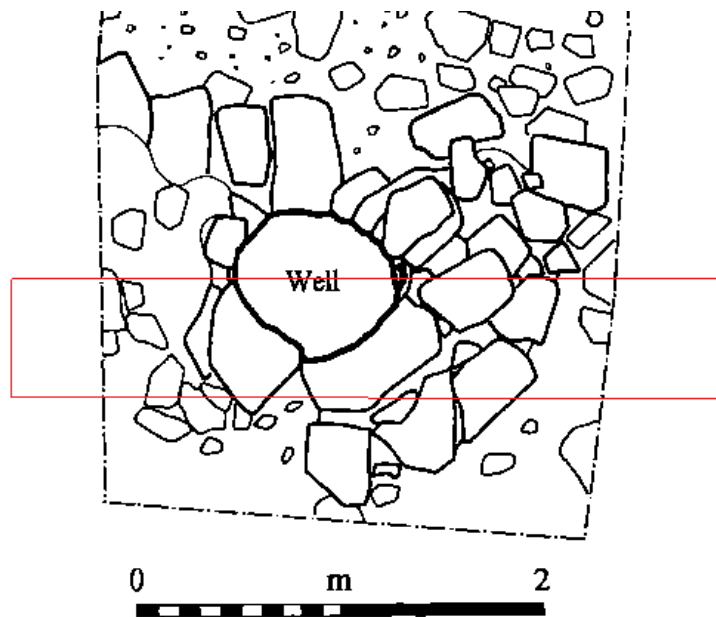
In order to rectify this, consideration might be given to the excavation of a small trench running E to W across the site of the well. The purpose of this trench is would be to:

- Ascertain what is under the cobbled surface
- Establish how far to the east and west archaeological material extends
- Determine whether this is a 19th century arrangement or something older.
- Establish the relationship between the well and the surfaces identified in 1987

Approximate location and size of proposed trench

The archaeologist will carefully lift the paving/cobbles, which will have been numbered during recording in order to facilitate reinstatement. Once the cobbles have been lifted, the archaeologist will excavate a narrow trench stratigraphically to the approximate depth required for the posts. If significant archaeological features are encountered, work will stop and assessment will be made as to whether it is appropriate to continue. If necessary the trench may be extended to make sense of archaeological deposits, although should this be necessary, HES Heritage Management will be consulted in advance.

Following investigation, the test trench will be lined with a permeable membrane and backfilled. The rest of the area around the well which was cleared for recording will also be covered and backfilled in the same way.
