**MILITARY PRISON
CONSERVATION WORKS
EAST ELEVATION
SMC**

BUILDING	Edinburgh Castle
PROJECT	Military Prison Conservation Work to Military Prison

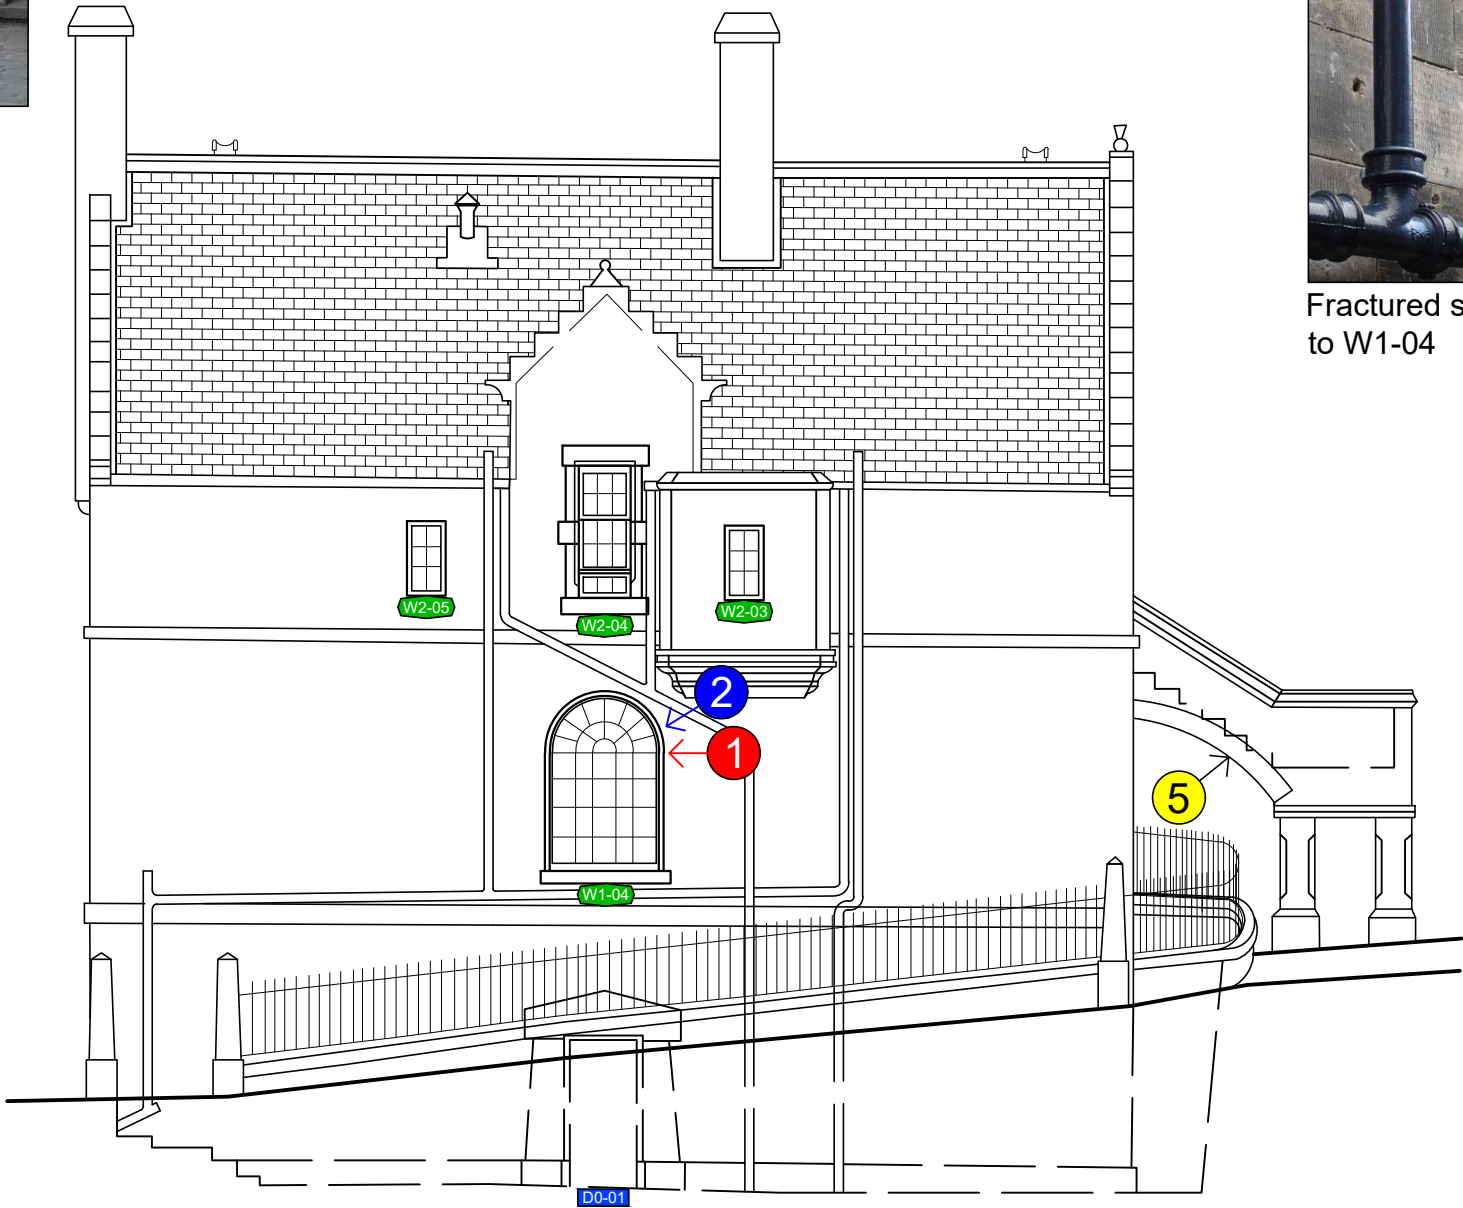
Military Prison - East Elevation
(Scale 1:100)

- Notes:
- Key
- 1 Indent required
 - 2 Fractured stone
 - 3 Vent grille missing
 - 4 Existing mortar
 - 5 Iron arch supports, prepare and redecorate

Masonry to be inspected from scaffold and any defects reported to the DA for further instruction. It is anticipated that a maximum of 15% of the facade areas will need repointing. Mortar mix to match existing, based on mortar analysis.

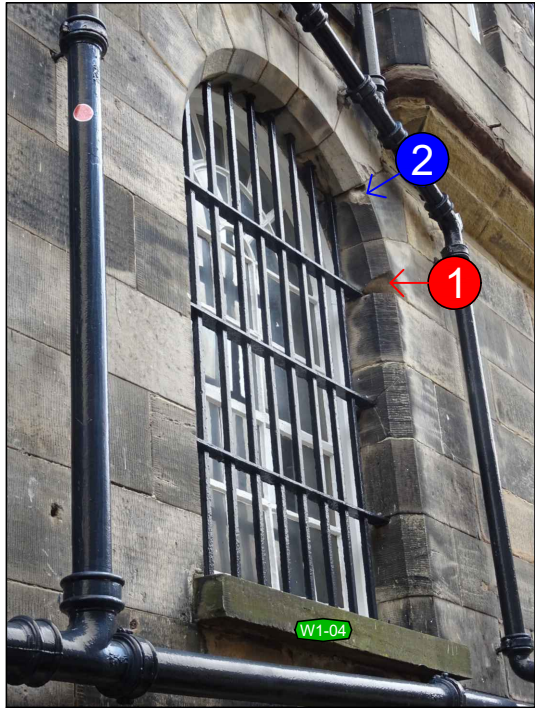
Fractured stone and indent required to W1-04
