**MILITARY PRISON  
CONSERVATION WORKS  
WEST ELEVATION  
SMC**

| BUILDING | Edinburgh Castle |
| PROJECT | Military Prison<br>Conservation Work to Military Prison |

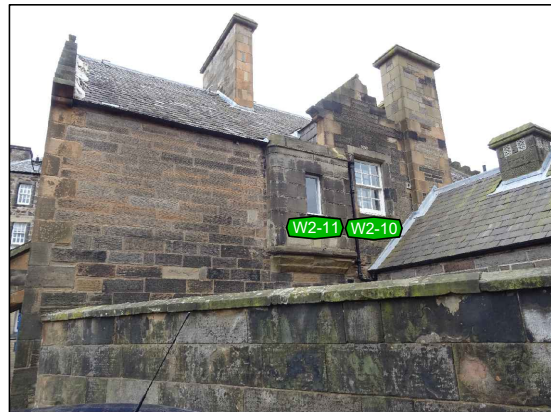
Northerly section of West Elevation

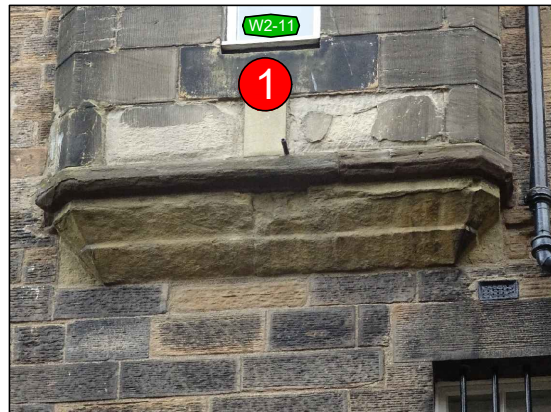
Stone indents required below W2-11

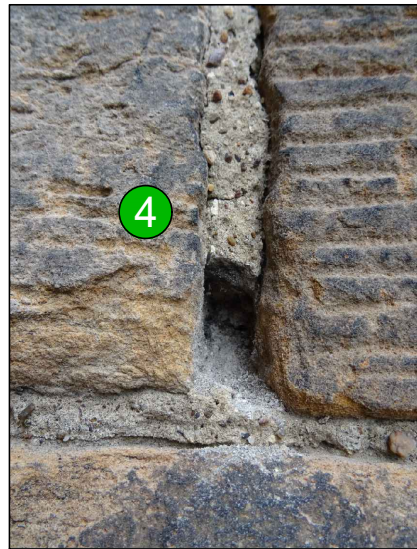
Typical example of existing mortar

Masonry to be inspected from scaffold and any defects reported to the DA for further instruction. It is anticipated that a maximum of 60% of the facade areas will need repointing. Mortar mix to match existing, based on mortar analysis.

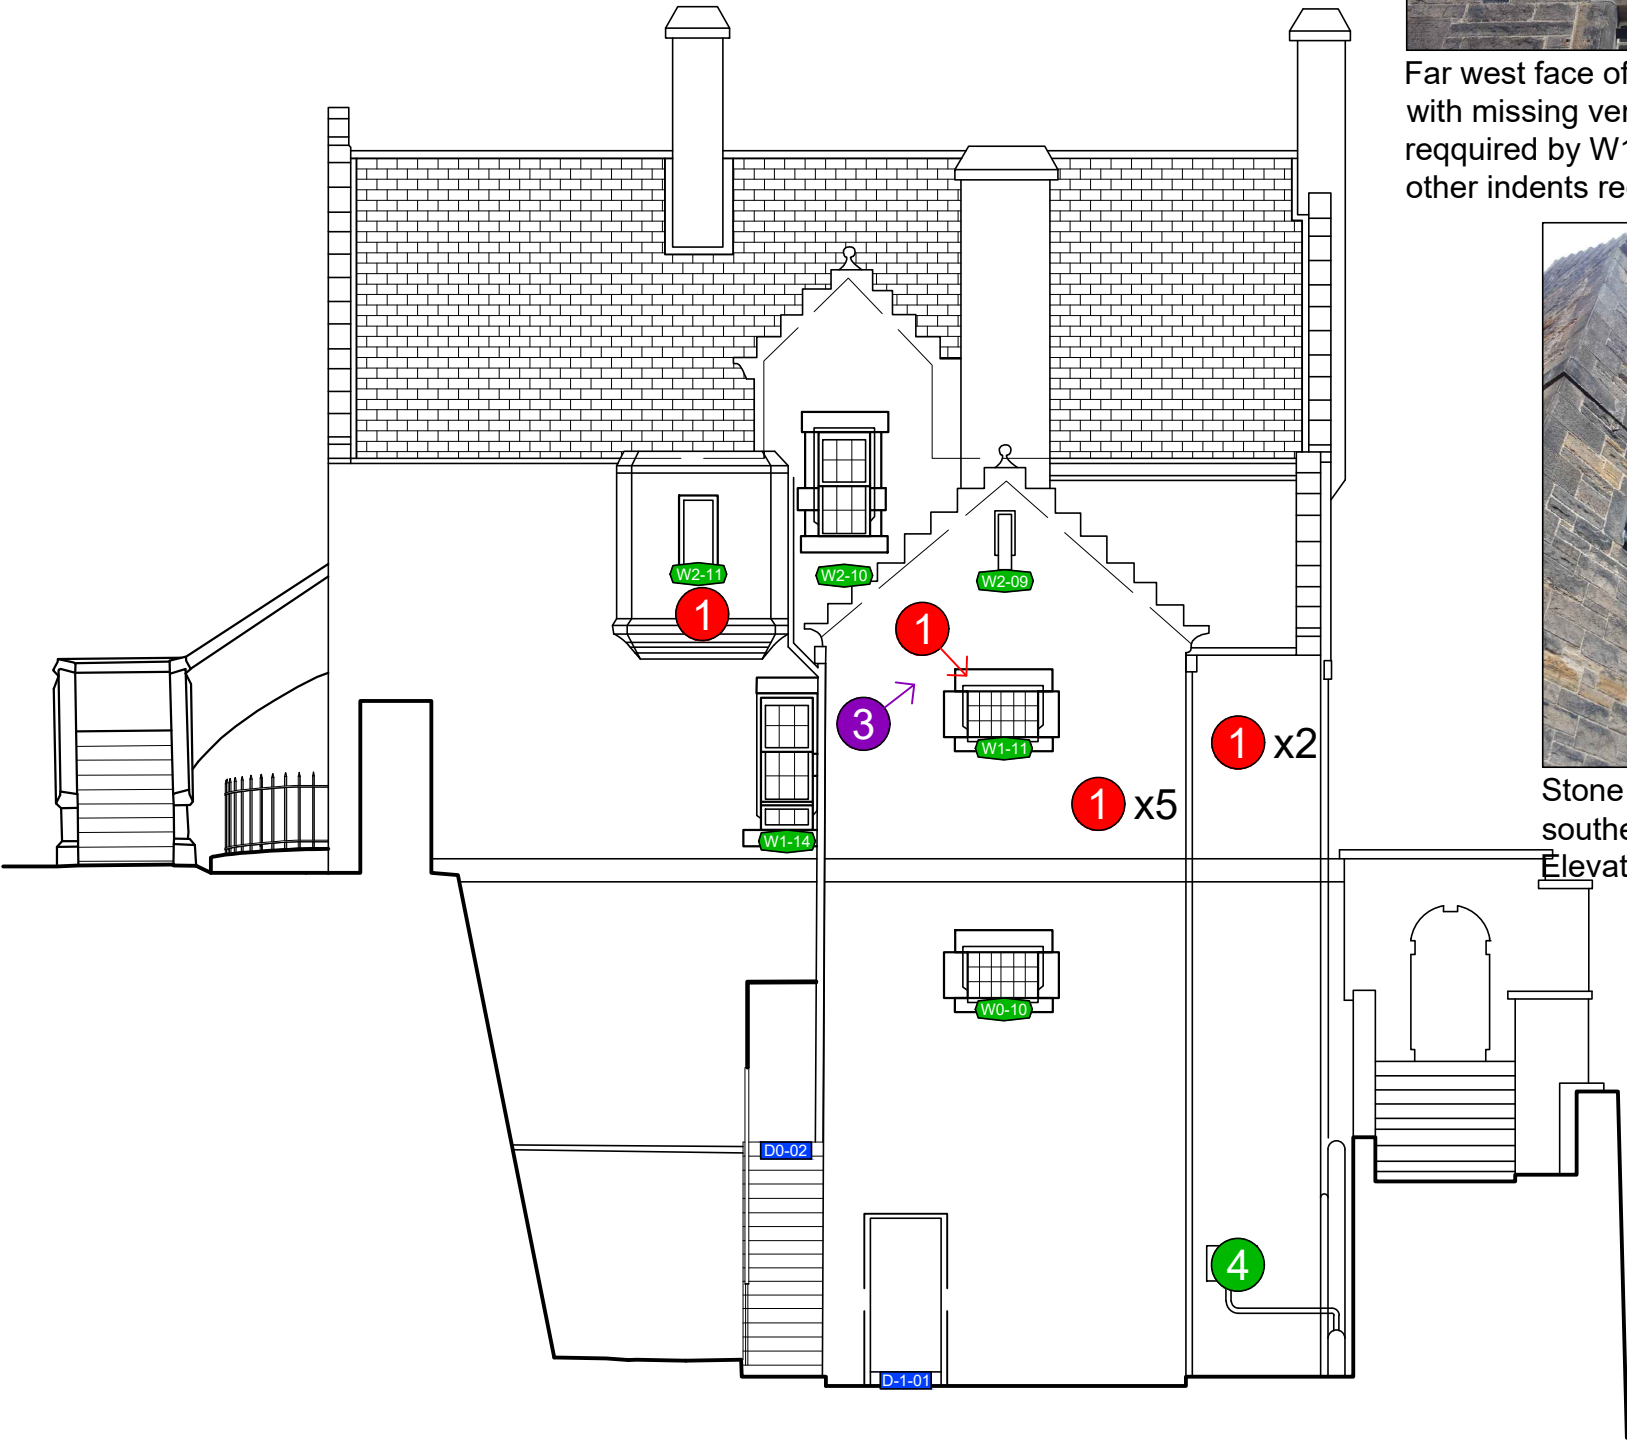
Military Prison - West Elevation  
(Scale 1:100)

- Key**
- 1 Indent required
  - 2 Fractured stone
  - 3 Vent grille missing
  - 4 Existing mortar
  - 5 Iron arch supports, prepare and redecorate

All cast iron and lead rainwater goods will be inspected and repaired if necessary.

Slated roof slopes, flashings, skews etc. to be inspected, and any remedial works to match existing.

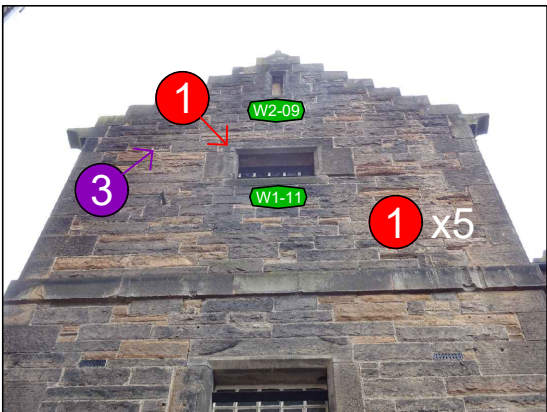
Far west face of West Elevation,  
with missing vent grille, an indent  
required by W1-11, and various  
other indents required

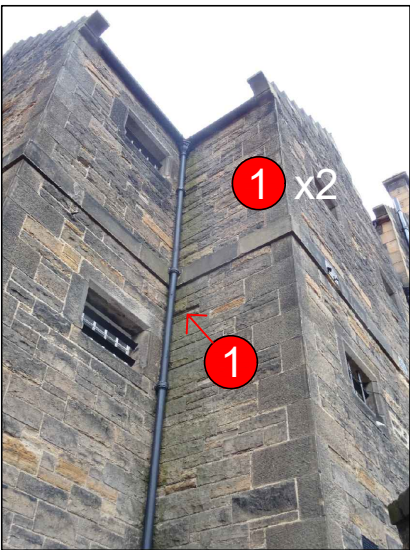
Stone indents required on  
southerly section of West  
Elevation
