| <b>Project:</b><br>Kinloss Abbey<br>2015/2016 | | <b>Drawing Title:</b><br>Proposed Works to Kinloss Abbey<br>ABBOT'S HOUSE, KINLOSS ABBEY | |
| | <b>Drawing Number:</b><br>38320-03 | <b>Revision:</b> | |

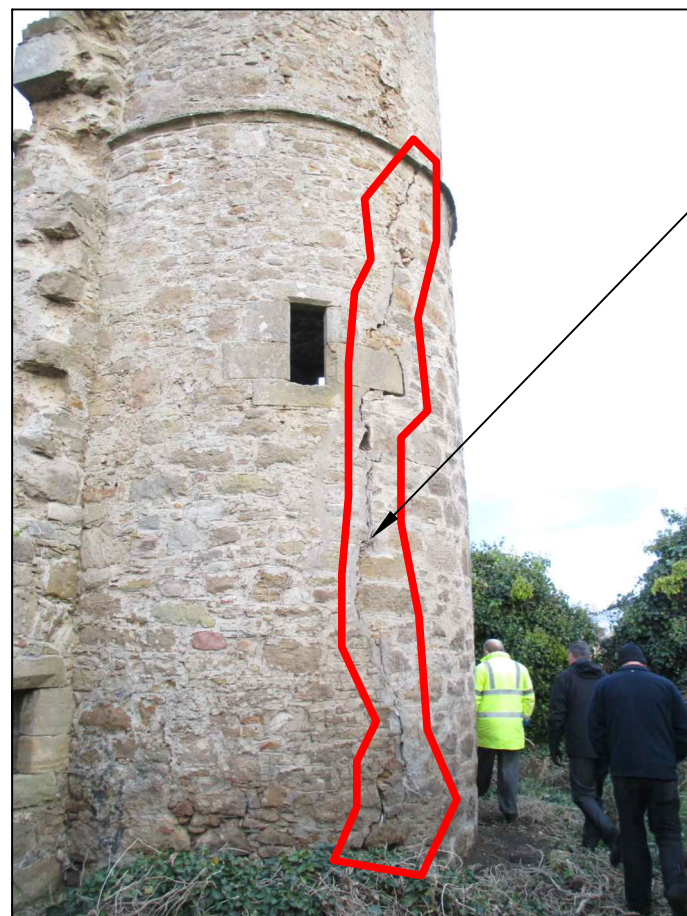
major vertical crack on external face to to be re-pointed and pinned with slate and sandstone.Lime to be grouted in section by section from bottom to top.

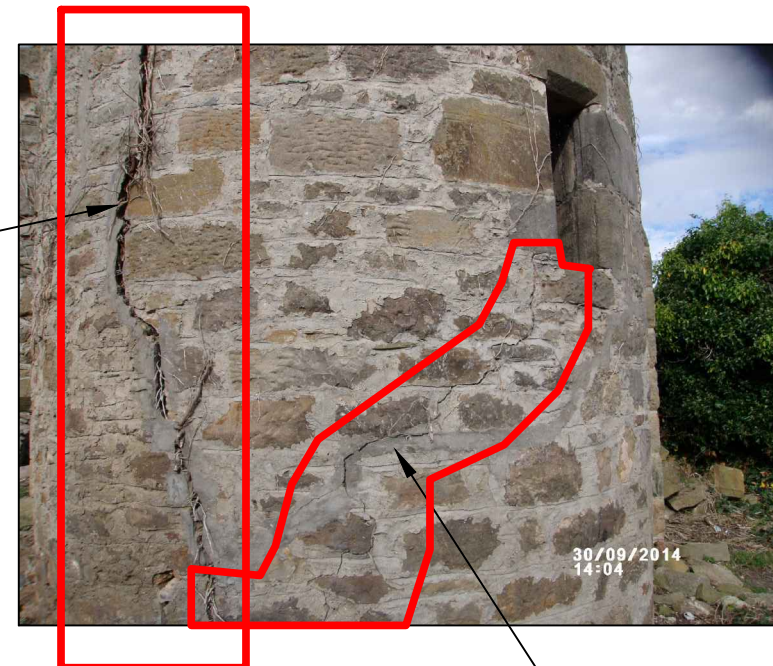
major crack on external face to to be re-pointed and pinned with slate and sandstone.Lime to be grouted in section by section from bottom to top.

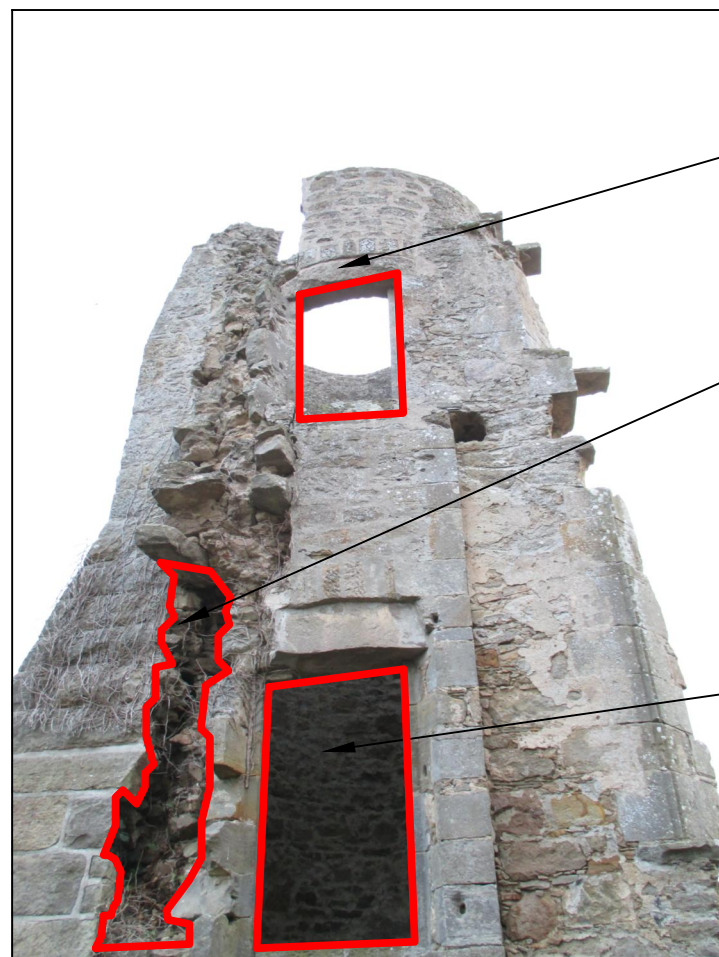
100 x 40mm stainless steel box section internal frame fixed to rybates to help stabalise lintel and LHS rybates.(As detailed by G.Laing stonecraft)

Large void to the left of the first floor doorway running from floor level to above the doorway lintel to be built up to secure.

Propping arrangement at doorway with mark II soldiers as detailed by speyside scaffolding services.

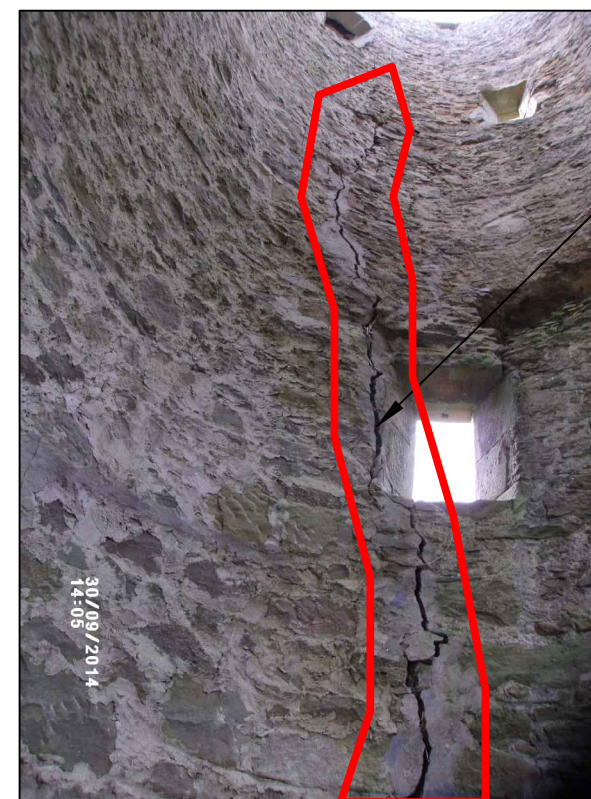
major crack on internal face to to be re-pointed and pinned with slate and sandstone.Lime to be grouted in section by section from bottom to top.
