# WRITTEN STATEMENT OF INVESTIGATION

ARCHAEOLOGICAL  
RECORDING

**JARLSHOF**  
GROUND MAINTENANCE

Historic Scotland

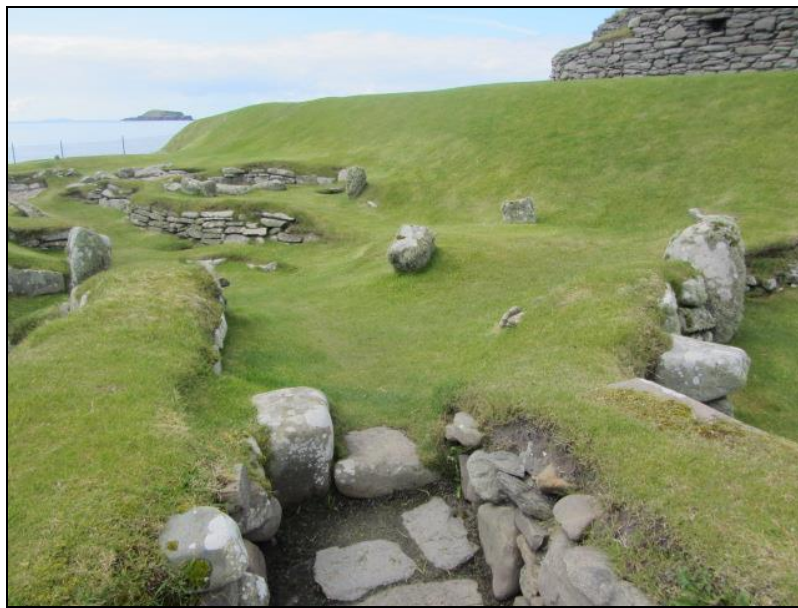
**Figure 2:** Location for new sign.

In the area of prehistoric settlement, beyond dwellings II, III and IV is a grassed area with patches of exposed midden and partially exposed wall lines relating to the settlement. The existing turf cover is thinning in places, due to visitor footfall, and the ground is often wet. To reduce erosion and improve the management of this area of the site is proposed to restrict access. By reinstating turf cover and clarifying the distinction between interiors, exteriors and modern paths it is hoped to discourage visitor flow in this area. In addition to this a small sign will be added in the location shown in Fig. 6 to discourage access.

The sign will be a small stone plaque in the style of the audio guide number plaques. It will not require any ground disturbance for installation, and as such will not impact upon any underlying archaeological deposits. The exact location of the sign will be determined in consultation with HES Cultural and Natural Resources to ensure that it is not placed on top of any sensitive features.

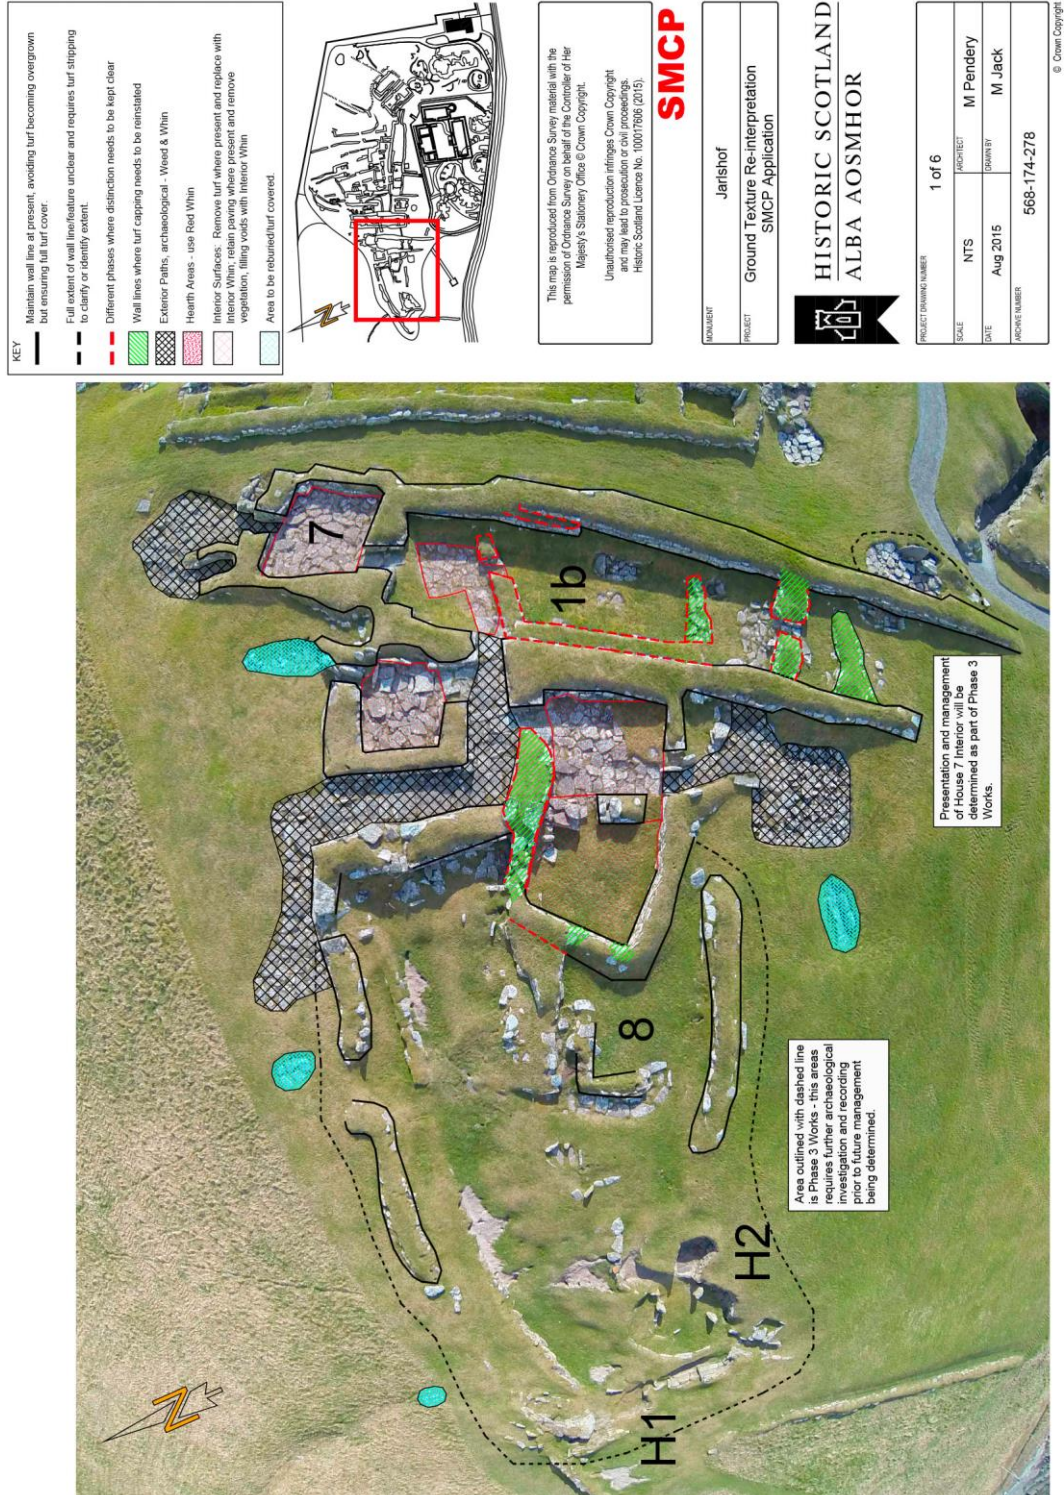
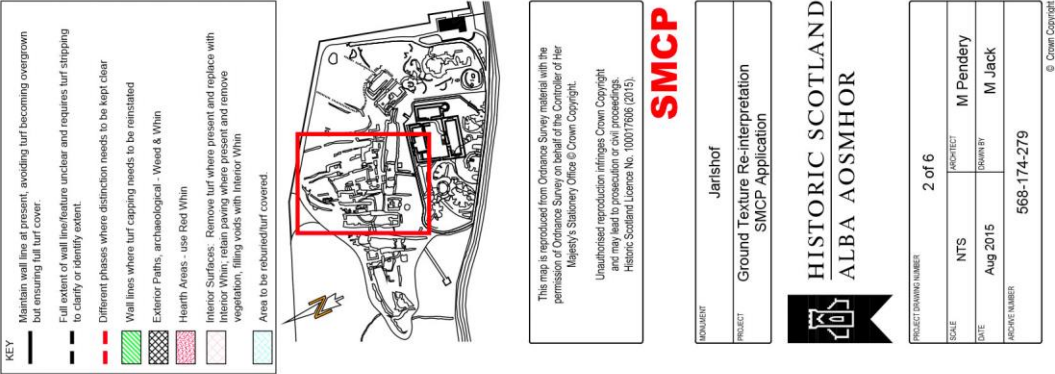
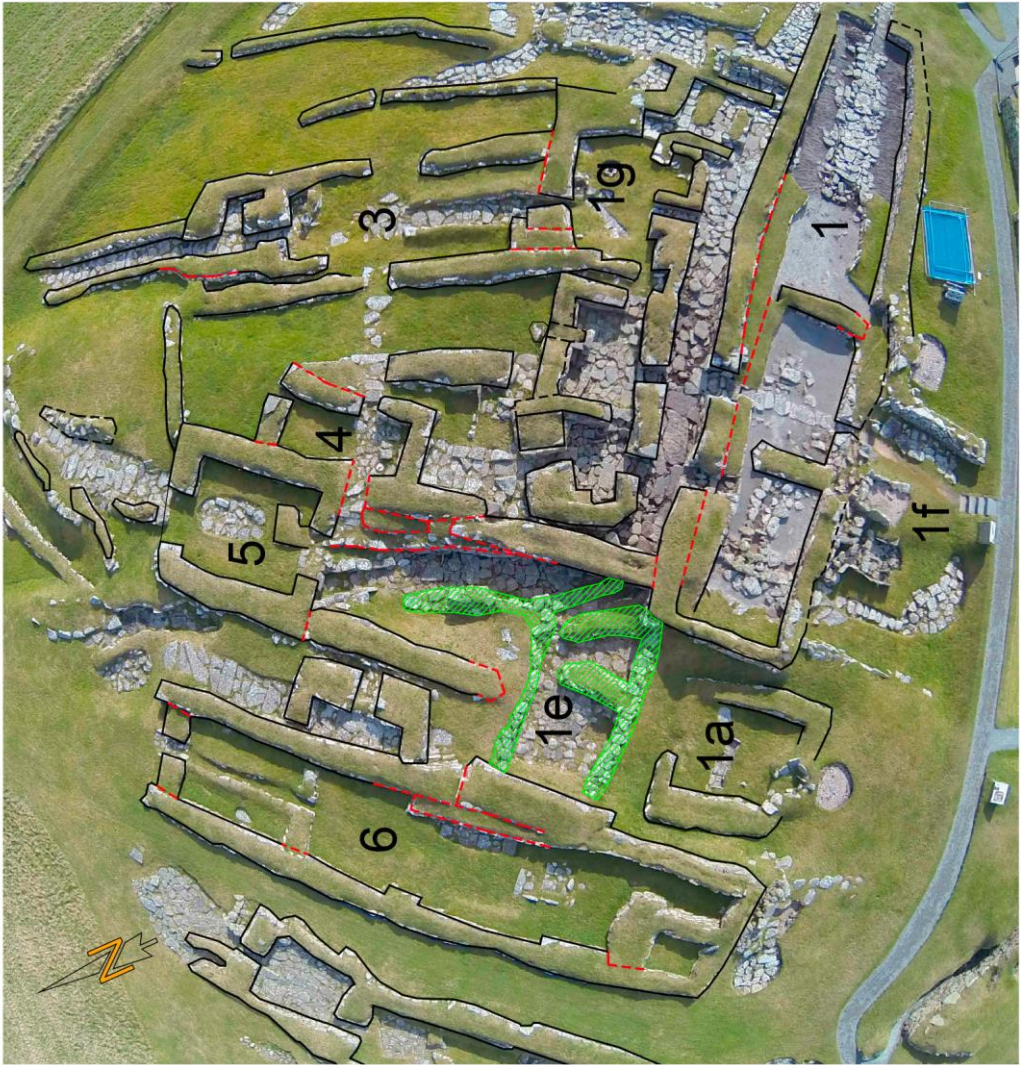
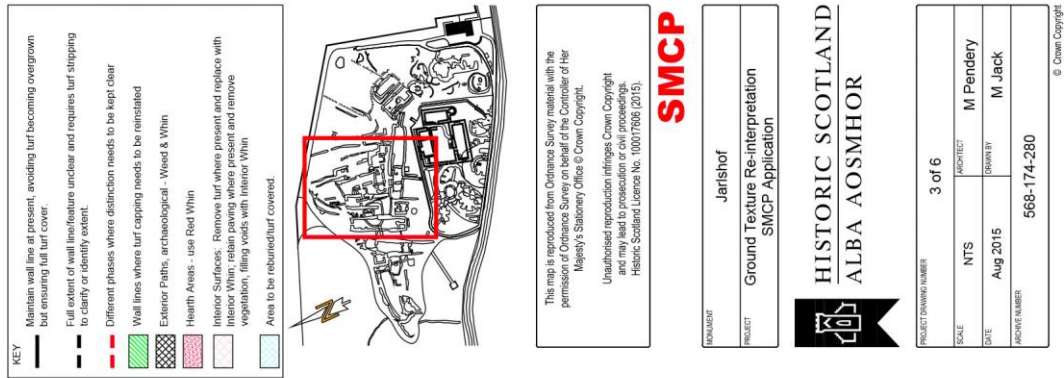
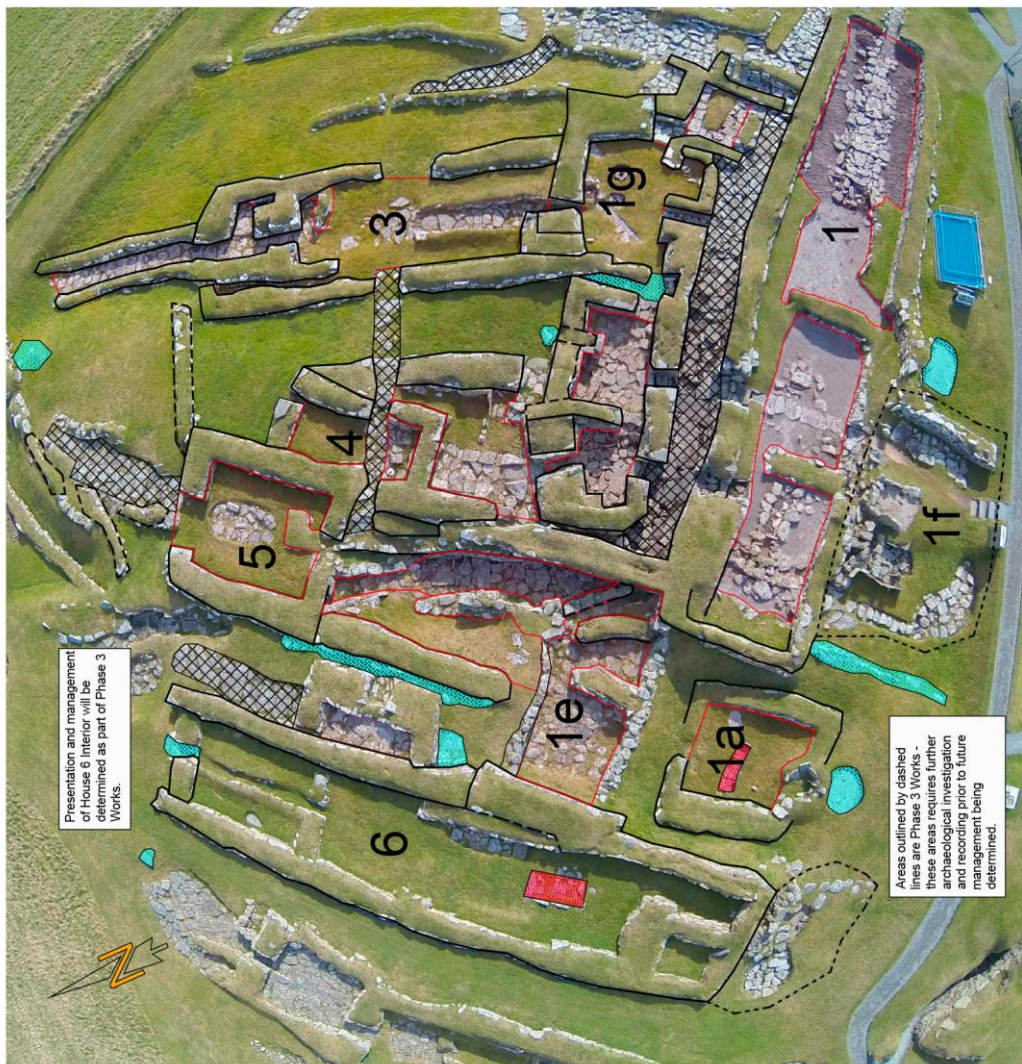
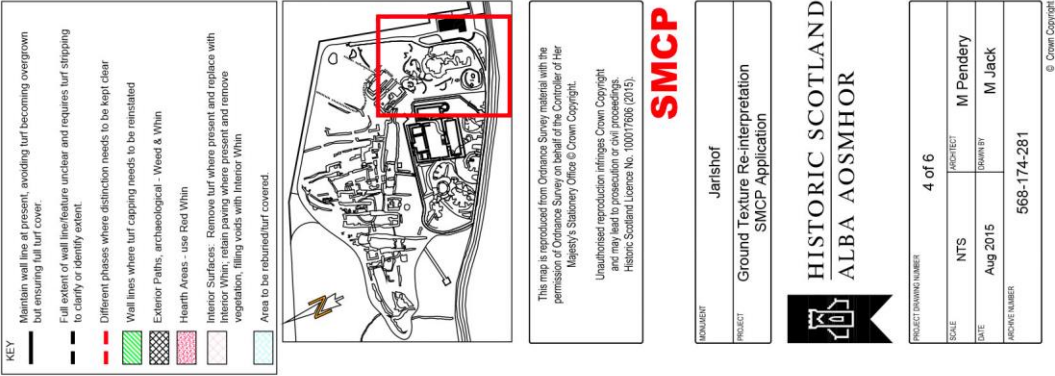
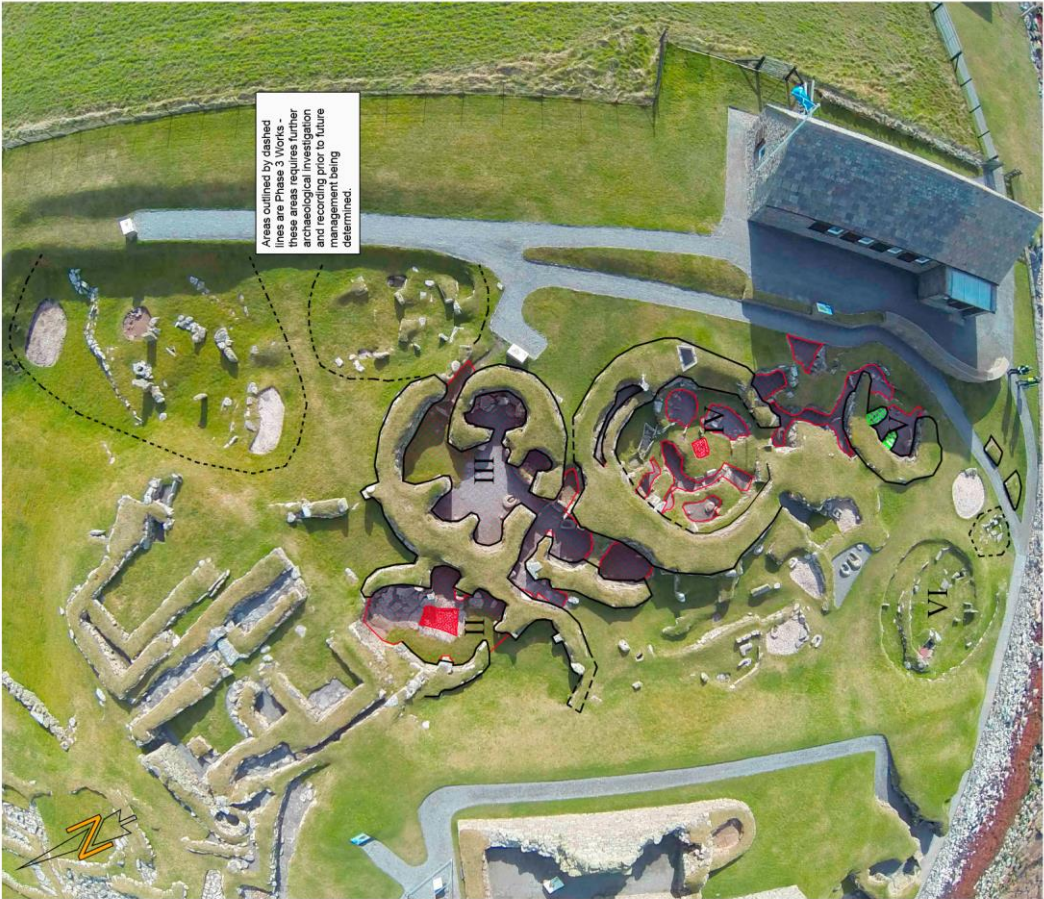
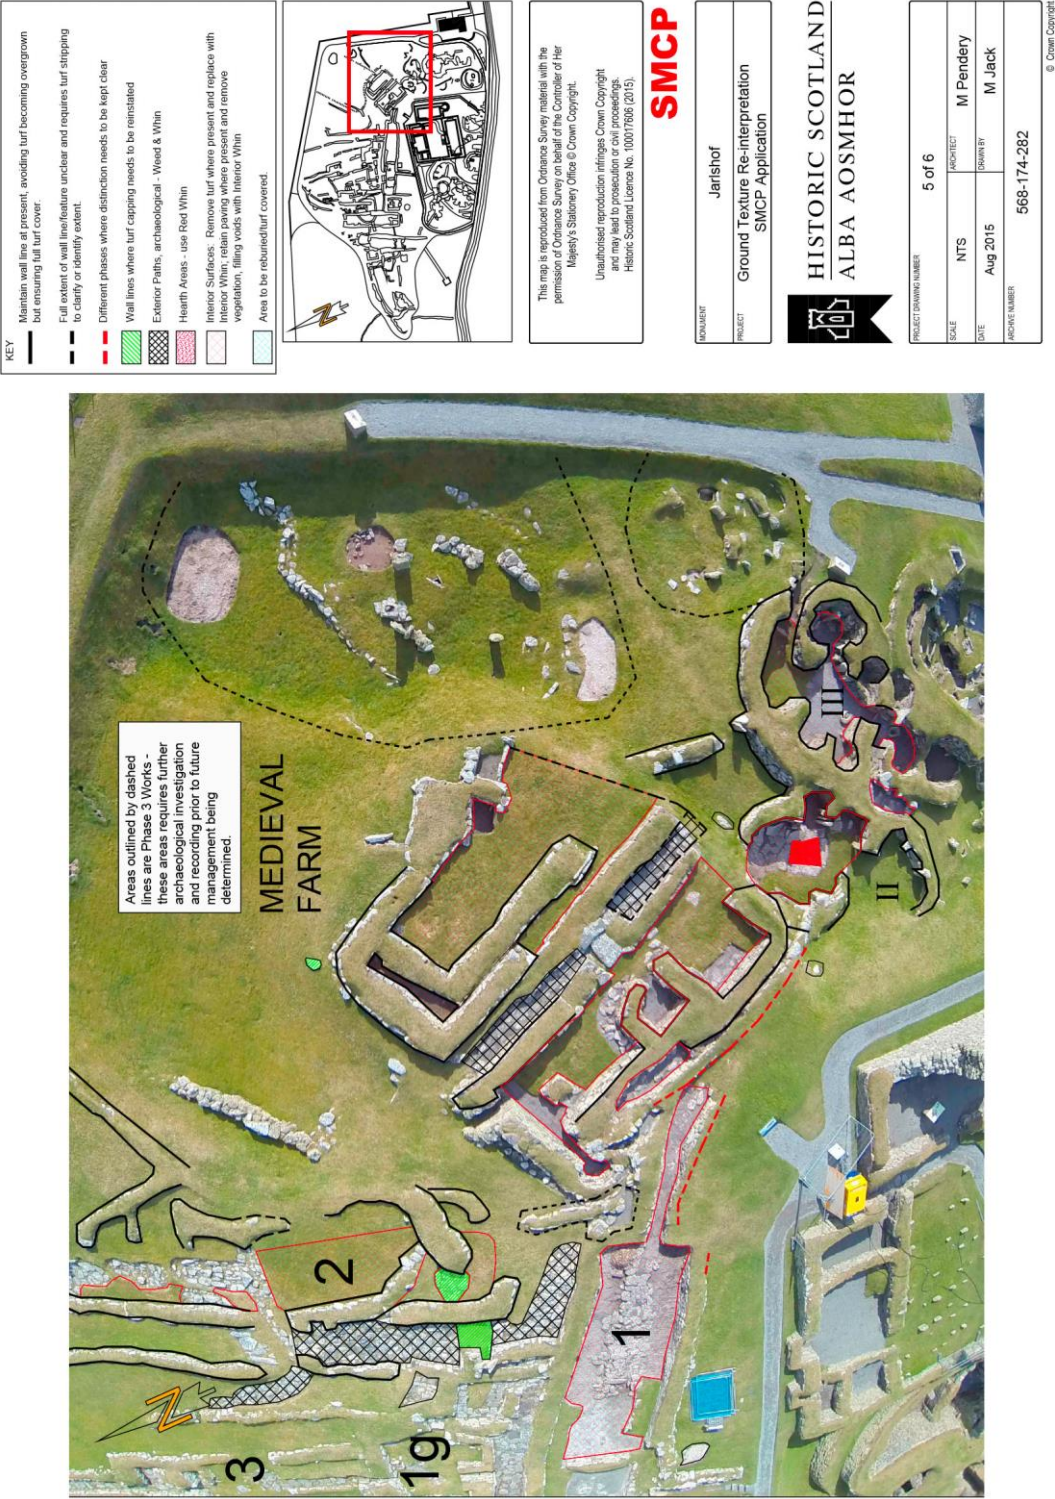
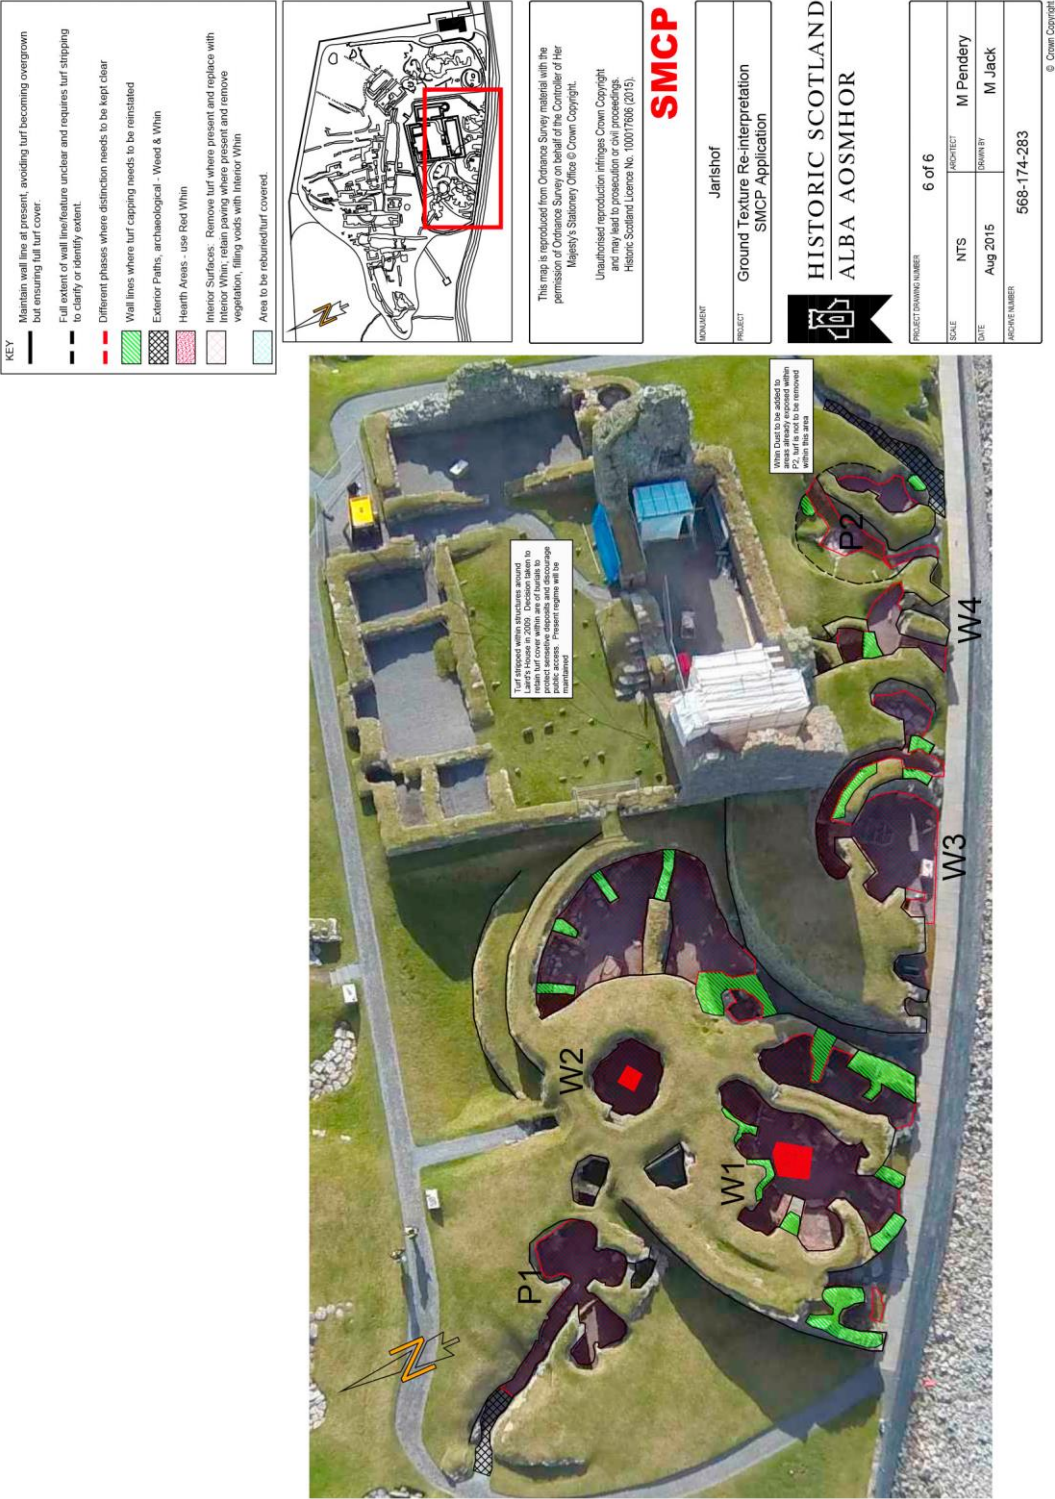
# APPENDIX A: GROUND TEXTURE RE-INTERPRETATION PLANS 1 - 6

In selected areas turf will be removed and replaced with gravel to define the interiors of buildings; there will be a few exceptions to this in areas of greater archaeological sensitivity. Where possible, this should be different from that used for modern paths so as to distinguish between modern and historic surfaces. Red gravel will be used for hearth features within structures. Details of the proposed changes are shown on the supporting plans.
