Jarlshof

Proposal for new grounds maintenance regime and changes to site presentation

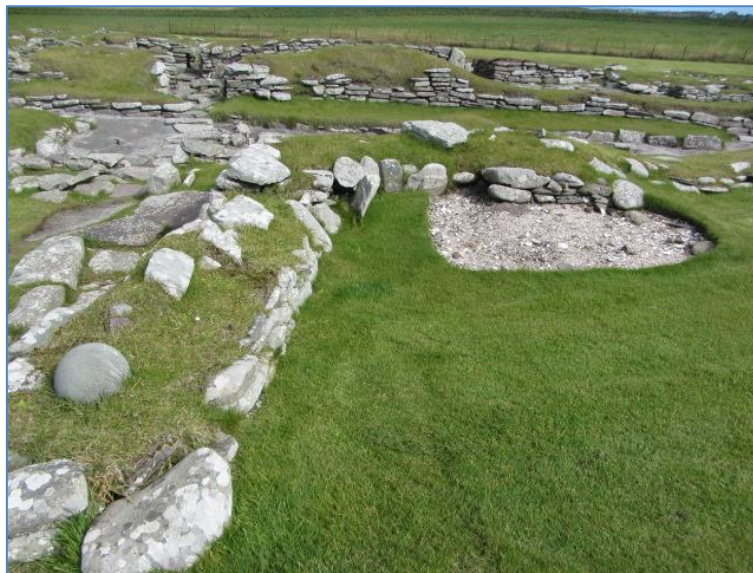
Fig 1. Midden associated with Norse settlement.

It is proposed that the middens in the area of prehistoric settlement in the east of the site remain as they are at present, as they are an important element of the archaeology of the site, and add to visitor interest – they are also included in on-site interpretation and the audio guide. However, the small sections of exposed midden within the Norse settlement will be reburied, to prevent further disturbance of these exposed deposits and to remove a layer of complexity from the site. The small midden areas in the Norse settlement are not currently interpreted and do not add to visitor understanding. Covering these remains will allow for easier maintenance of these parts of the site, therefore reducing staff time required in the maintenance of these areas.

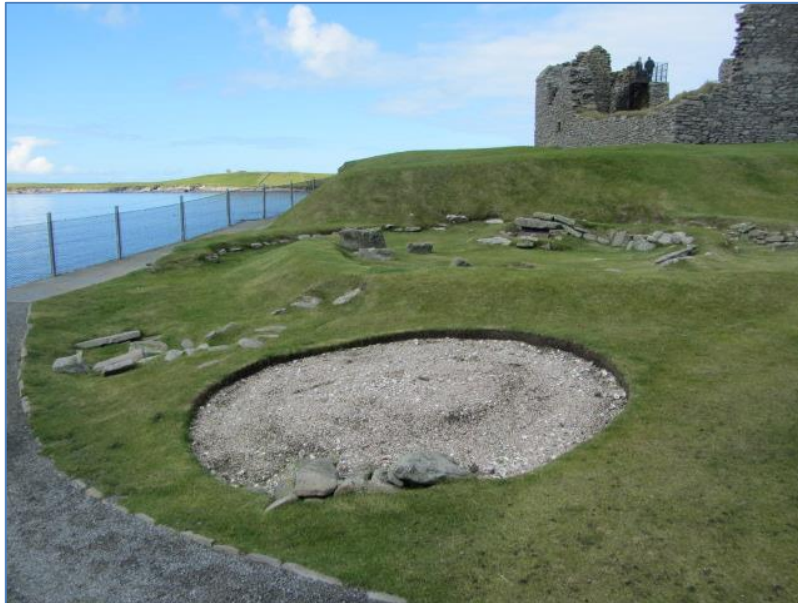
Fig 2. Midden adjacent to dwelling VI.

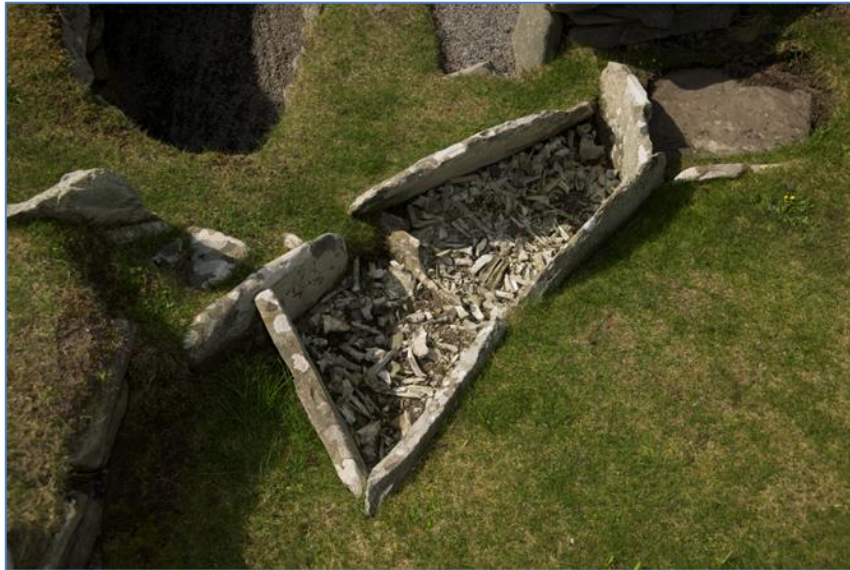
Within dwelling IV of the Bronze Age settlement there is a deposit of mixed animal bones within a stone box. This feature was identified and excavated by Curle in 1932⁵ and it is likely that the present remains have subsequently been added to/taken away from and mixed since their initial discovery. However, part of the original archaeological deposit remains and is exposed and open to the elements. As with the shell midden, this material is often disturbed and displaced and so reburial is proposed for these remains.

Fig 3. Close-up of animal remains deposit in stone box within dwelling IV.

Removal of the animal bone was considered to be beyond minimal intervention – it would require archaeological input and costs would be involved to appropriately conserve the remains. Covering the deposit will prevent further disturbance or mingling of these remains and means that it can remain in-situ. However, it would also remove an element of understanding and interpretation from the site. As above for the midden deposits, these remains have been excavated, disturbed and left exposed, and it is unlikely that maintain the status quo will have a significant impact upon the archaeological resource. It is therefore recommended to leave the remains in situ as they are at present, though this may be reviewed in the future if necessary.

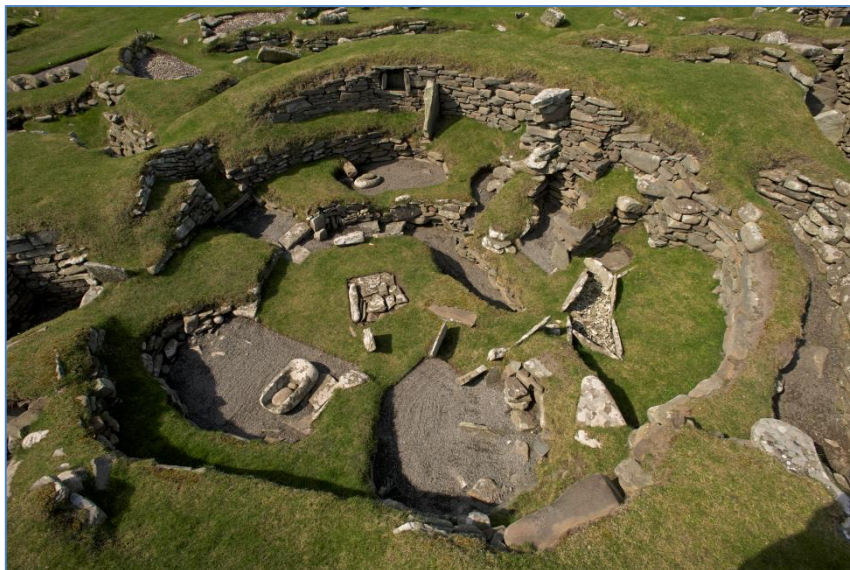
Fig 4. Stone box in context, within dwelling IV.

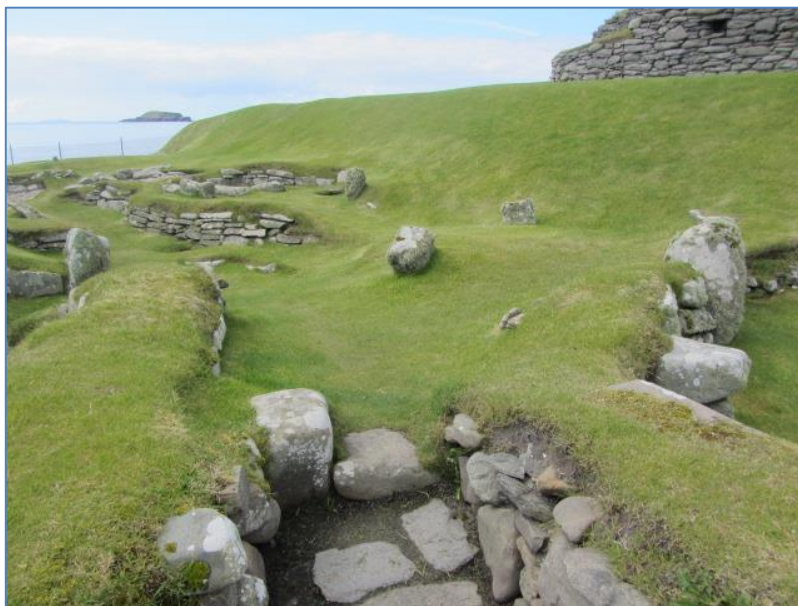
In the area of prehistoric settlement, beyond dwellings II, III and IV is a grassed area with patches of exposed midden and partially exposed wall lines relating to the settlement. The existing turf cover is thinning in places, due to visitor footfall, and the ground is often wet area. To reduce erosion and improve the management of this area of the site is proposed to restrict access to this area of the site. By reinstating turf cover and clarifying the distinction between interiors, exteriors and modern paths it is hoped to discourage visitor flow in this area. In addition to this a small sign will be added in the location shown in fig. 5 to discourage access.

Fig 5. Location for new sign.

The sign will be a small stone plaque in the style of the audio guide number plaques. It will not require any ground disturbance for installation and as such will not impact upon any underlying archaeological deposits. The exact location of the sign will be determined in consultation with HES Cultural & Natural Resources to ensure that it is not placed on top of any sensitive features.

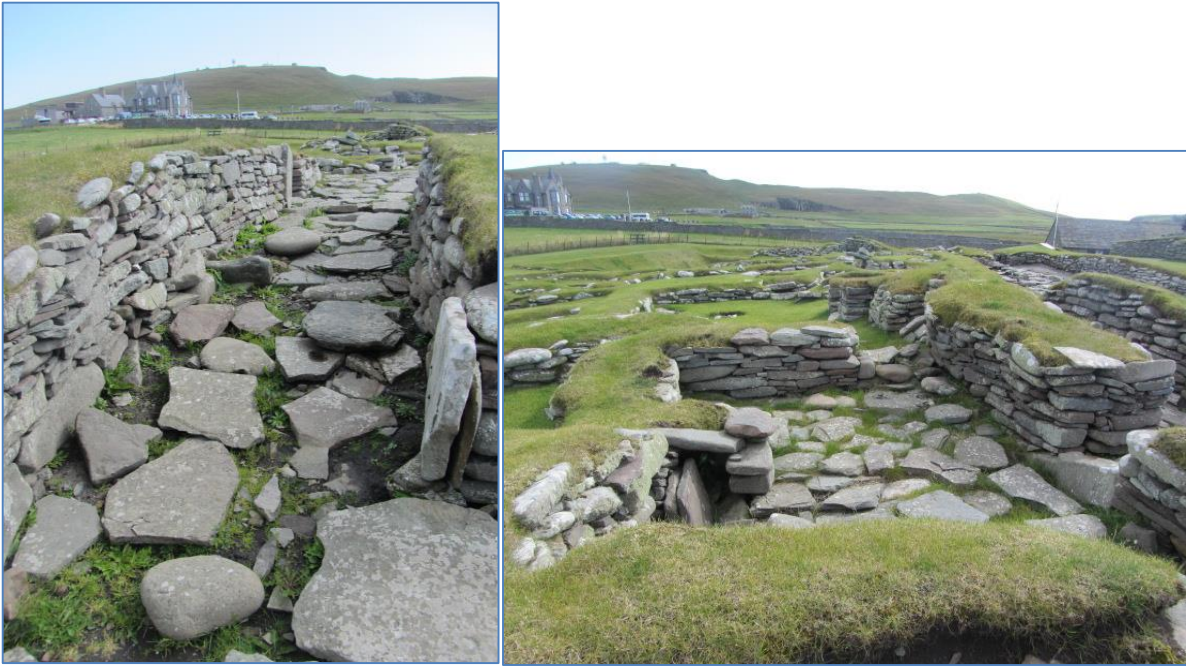
Historic paving is present in an number of areas within the Norse and Medieval settlement, forming interior floor surfaces or paths alongside a number of the structures. The paved areas within the Norse settlement were reinstated following Hamilton's excavations. However, these surfaces have become loose and uneven in places and weeds are growing around and between the paving stones. It is recommended that historic paving be retained, consolidated and weeded, where it is already present within structures or along pathways. This will improve the overall presentation and management of the site and should make the paved pathways easier to understand.

Figs 6 & 7. Examples of paved areas to be consolidated, vegetation removed and paving relayed and surrounded by fine gravel.

Vegetation around the paving stones will be removed by hand. Consolidation of the paved areas will require a small amount of ground disturbance to create a level foundation for the re-laid stones, with excavation extending to a maximum depth of 100mm. The paving stones will be carefully lifted by hand, the ground will be levelled and a geotextile layer laid, the paving stones will then be re-laid in their original position⁶ as far as possible, with voids between the stones filled with fine gravel. In the Norse settlement, where paving is found on interior and exterior surfaces, different gravel will be used to differentiate between interiors and exteriors as far as possible, adding greater consistency to the presentation of structures across the site.

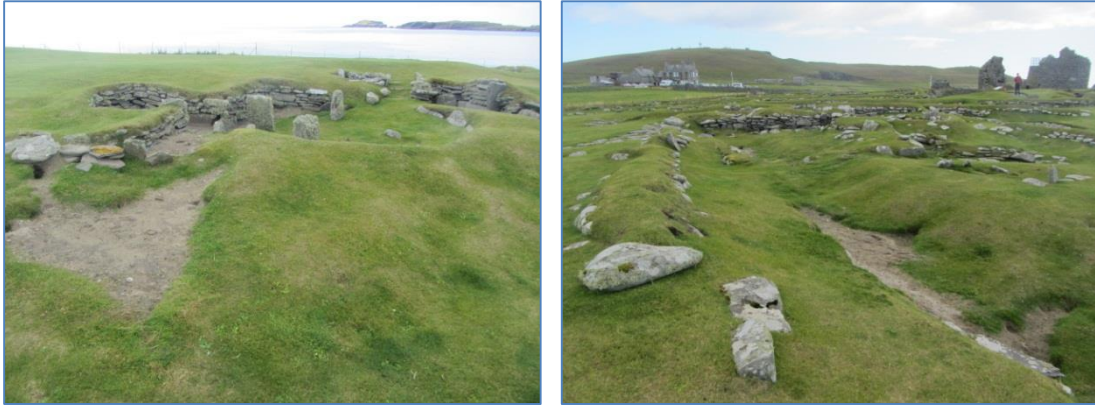
The west area of the site is suffering from on-going rabbit infestation. The extent of damage caused to archaeological deposits and structures is unclear, though from aerial photographs it is clear that the appearance of the site has changed as a result of burrowing and not all of the features recorded by Hamilton at the time of excavation and consolidation are still clear on the ground. A programme of archaeological investigation and recording is proposed for this part of the site to investigate the extent of rabbit damage before developing plans to deal with the issue. This will include geophysical and topographic survey, followed by targeted archaeological evaluation. A separate method statement has been produced which details the proposed works.

Figs 8 & 9. Iron Age settlement remains to the west of the Norse settlement suffering from rabbit damage.

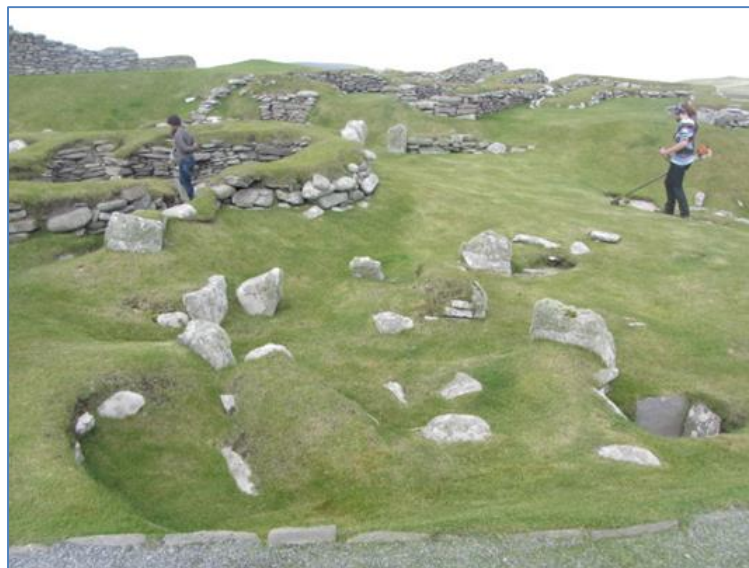
In an number of places at Jarlshof the previous extent of excavation, or present degree of survival is unclear and there are areas where the exposed remains no longer reflect the structures indicated on Hamilton's plans. These areas are indicated on the accompanying plans.

Fig 10. Exposed structures and stonework within the Bronze Age settlement; these remains do not clearly relate to existing site plans.

These areas will require further investigation before a future management regime can be determined; the status quo will be maintained at present, but archaeological investigation (including geophysical survey) and recording will be proposed at a future date and will form a separate SMC application(s) with individual desk-based assessments and methodologies.

Turf-stripping and archaeological excavation down to previous levels will allow us to determine the extent and nature of surviving structures and will provide an opportunity to more accurately record the archaeological remains on site, where this has become unclear over time due to turf encroachment and changes to the management of the site. Once these areas have been investigated and recorded a decision will be taken on how best to manage and present the archaeological remains. In some cases this will involve reburial of the remains, if the structure is fragmentary and where this would not impact upon overall understanding and interpretation of the site.
