# HUNTLY CASTLE

## Survey of stone frieze and other ornamental stone

**September 2015**

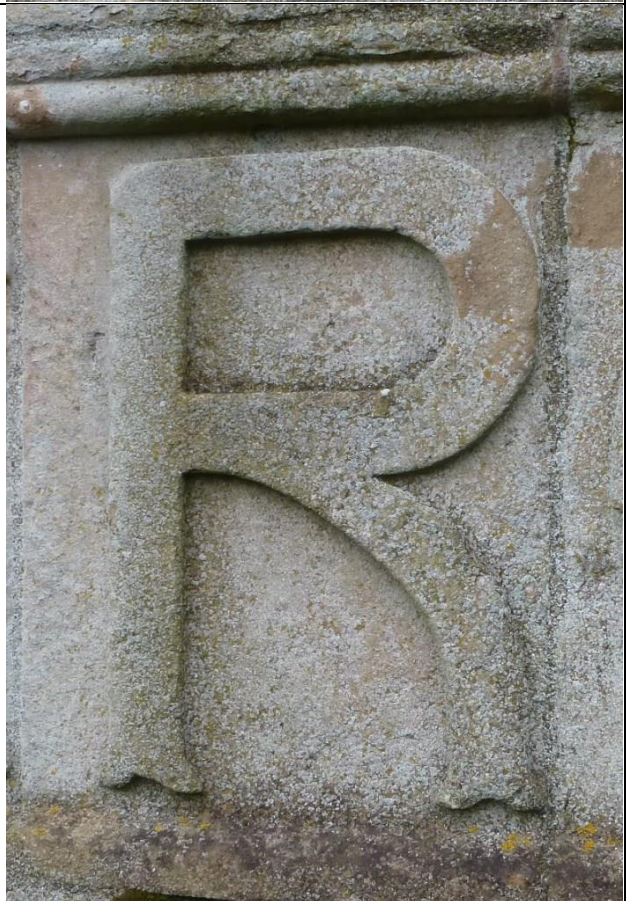
R – stable, largely covered in thin lichen growth.

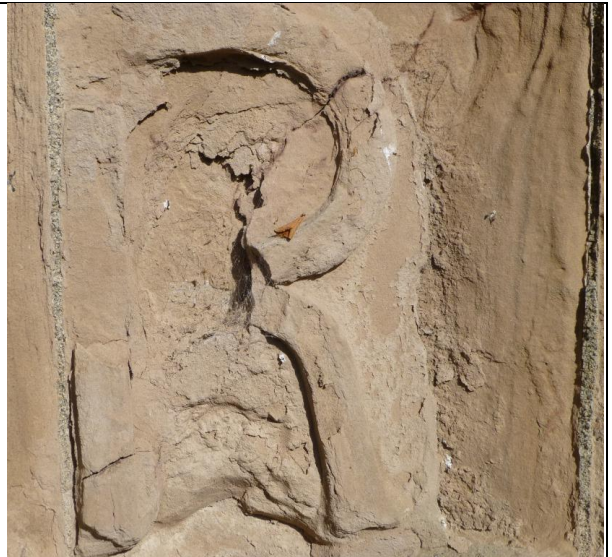
Stone after removal of the letter 'R'

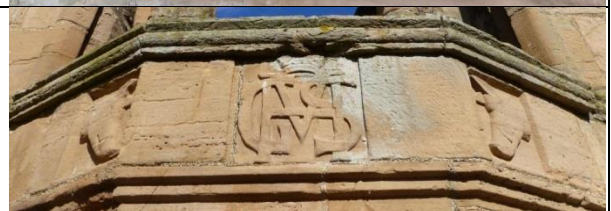
Carved boar heads and lettering above 'Henriette' - open bedding planes and minor fissures.

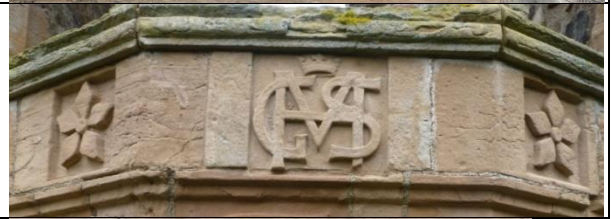
Carved flowers and lettering above 'Marquisse' – open bedding planes

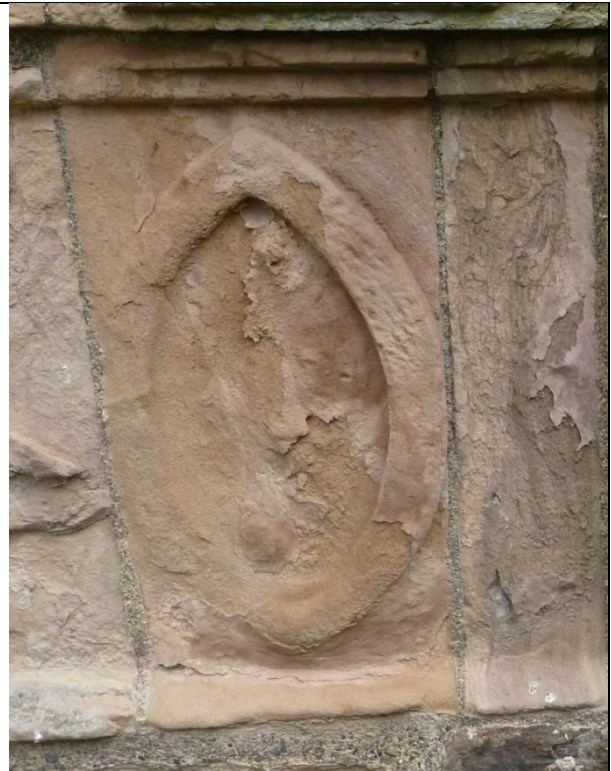
O – The central area of the stone suffers extensive surface blistering and exfoliation, possibly of a surface consolidated section of the stone, is occurring.

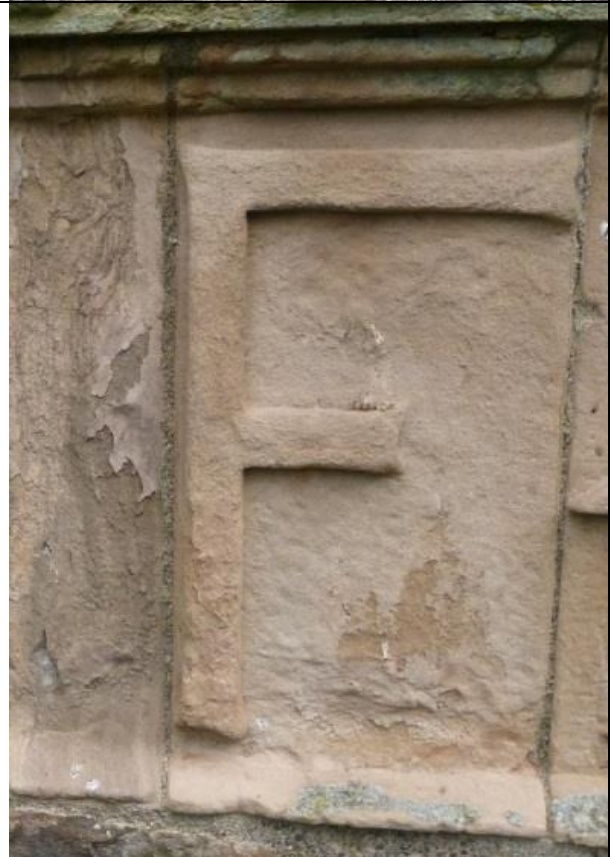
F – Surface exfoliation and disaggregation of lower part.
